Gunstock Brook Watershed Stream Geomorphic Assessment Gilford, New Hampshire July 9, 2012

Prepared by:
Bear Creek Environmental, LLC
297 East Bear Swamp Road
Middlesex, Vermont 05602

Prepared under contract to:
Belknap County Conservation District
2 Airport Road, Unit #1
Gilford, NH 03249

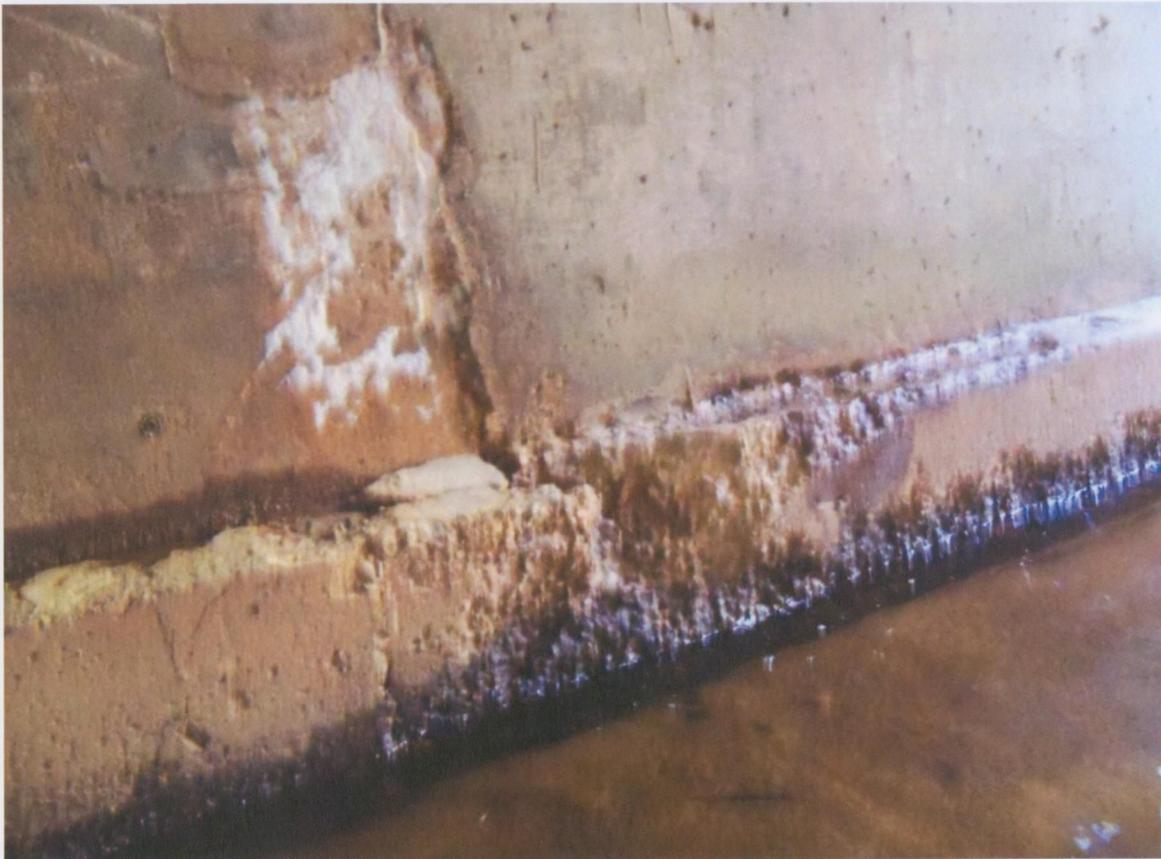
A total of eight structures were identified as high priority for replacement. Two of the high priority structures are culverts (Lakeshore Road and Town Garage Access Road) with no aquatic organism passage including adult salmonids. The Lakeshore Road Culvert was partially compatible and the Town Garage Access Road Culvert was mostly compatible. One of the high priority culverts (Trail to Lyman's) is mostly incompatible with reduced AOP. The most downstream Intervale Road crossing did not meet the criteria of high priority above, but was placed in the high priority category because of the poor alignment of the structure and the resultant impacts. The bridge at Old Lakeshore Road also did not meet the criteria for high priority but was placed in this category due to its poor condition. A private trail bridge in segment M04-B was placed in the high priority category since it is failing and a debris jam is currently obstructing part of the bridge. It appears that the bridge is not being used so removal is recommended instead of replacement. Two bridges (Intervale Road, upstream and Cherry Valley Road) are significantly undersized and therefore placed in the high priority category. The Cherry Valley Road Bridge has deteriorating footers (Figure 7.1)

Figure 7.1. The Cherry Valley Road Bridge has deteriorating footers.

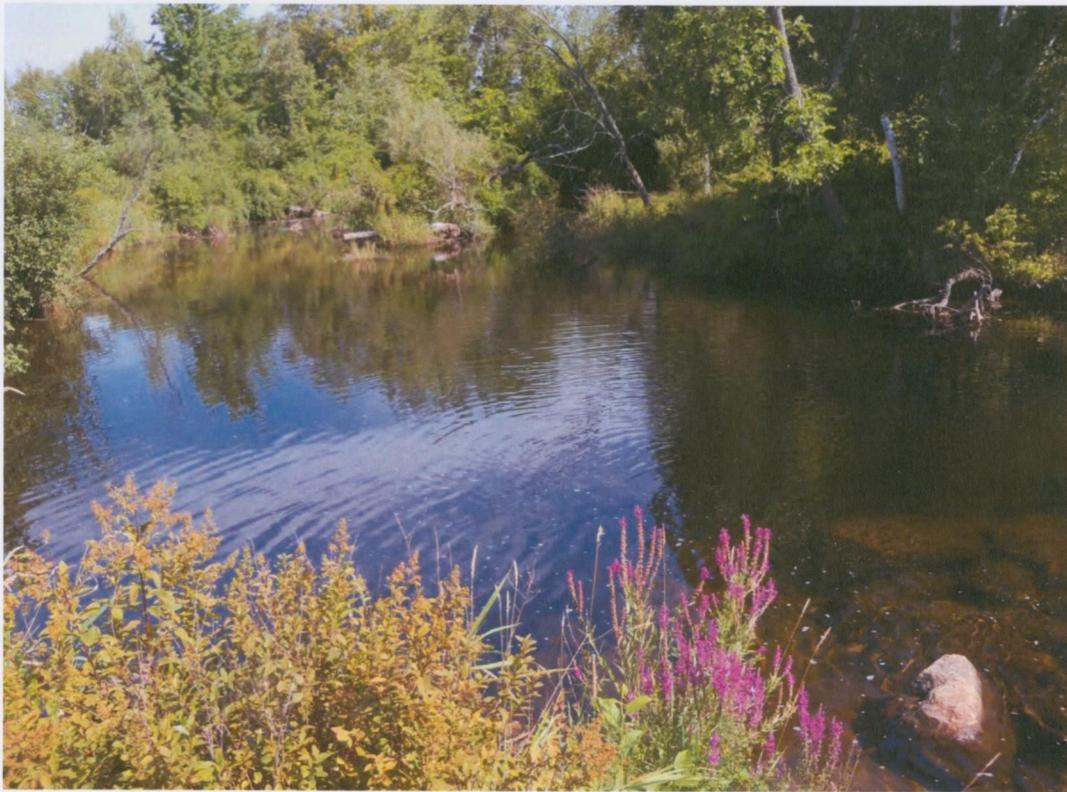
Figure 8.1. Impounded segment M01-A

The Natural Resources Conservation Service (NRCS) has recommended a streambank stabilization project (SB6) along the banks of an impounded section of Gunstock Brook upstream of the Route 11B crossing (Winnepesaukee Gateway, 2012, <http://winnepesaukeegateway.org/monitoring-the-lake/potential-restoration-sites-map>). The NRCS has also evaluated two bank erosion areas that are located downstream of Lakeshore Road. These locations are shown on the map on page 1 of Appendix B. All three of these proposed bank stabilization areas are located downstream of the Gunstock Brook study area that received a full phase 2 assessment by BCE. For this reason, BCE does not have information to guide a decision about bank stabilization in this location.

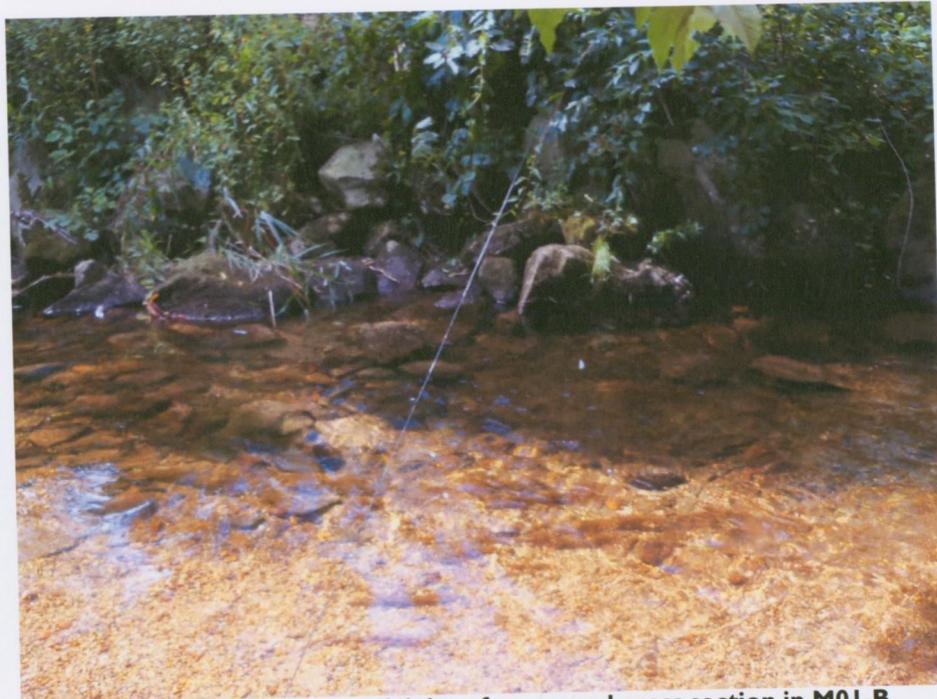
Segment M01-B begins just upstream of the Lakeshore Road crossing and continues upstream for 1,200 feet until Old Lakeshore Road. Extreme degradation has occurred in this segment due to the extensive channel alteration, which has resulted in a stream type departure from a "C" stream to a "B" stream. Widening is being prevented by the abundant riprap (Figure 8.2). Riprap is graded rock that is used to stabilize banks. The bedform has been altered from riffle-pool to plane bed (i.e. lacks defined habitat features) due to the channel alterations. The geomorphic and habitat condition of Segment M01-B are both "fair". The lack of large woody debris, embedded channel, lack of riffle habitat, and the lack of vegetation on both banks and in buffers has led to the "fair" habitat condition.

Figure 8.2 Rock riprap in vicinity of measured cross section in M01-B.

possible to plant additional trees back away from the bank to give them time to grow and establish root structure. If infrastructure, such as homes or the tennis courts are threatened, bank stabilization using rock armoring may be the only recourse to protect these investments. If a decision is made to armor the banks, a biotechnical approach is recommended, where the upper bank is sloped and planted and live cuttings are incorporated into the rock riprap. Existing large trees along the bank should remain to the extent feasible.

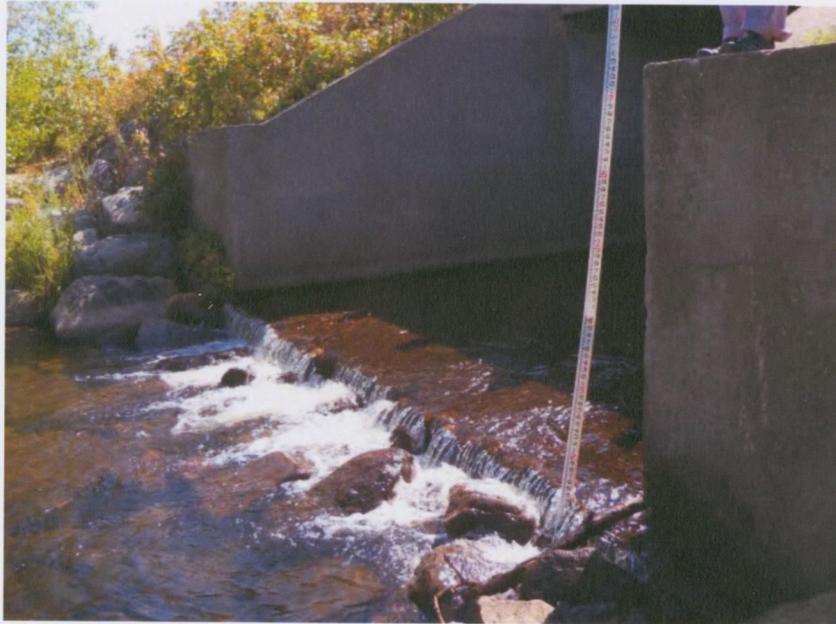
Figure 8.3. Perched box culvert at Lakeshore Road.

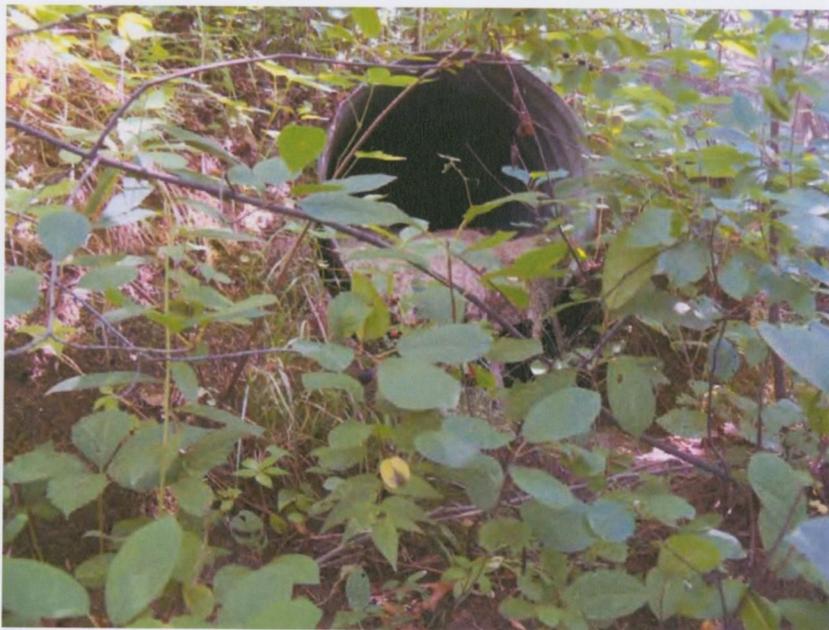
Figure 8.4 Sediment laden stormwater culvert along segment M01-B.

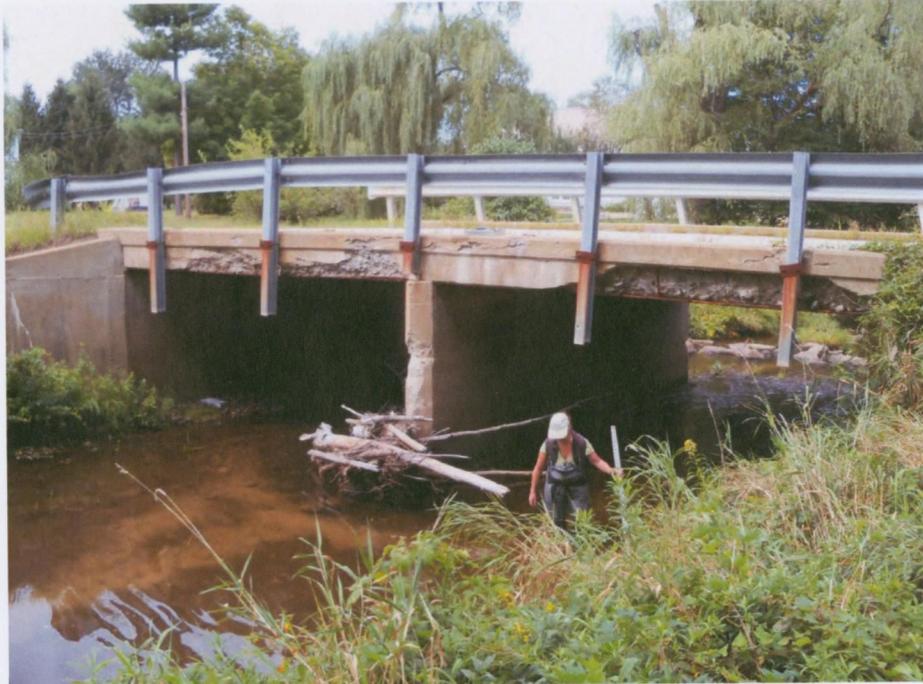
Figure 8.5. Deteriorating decking and pier of Old Lakeshore Road Bridge in Segment M01-B.

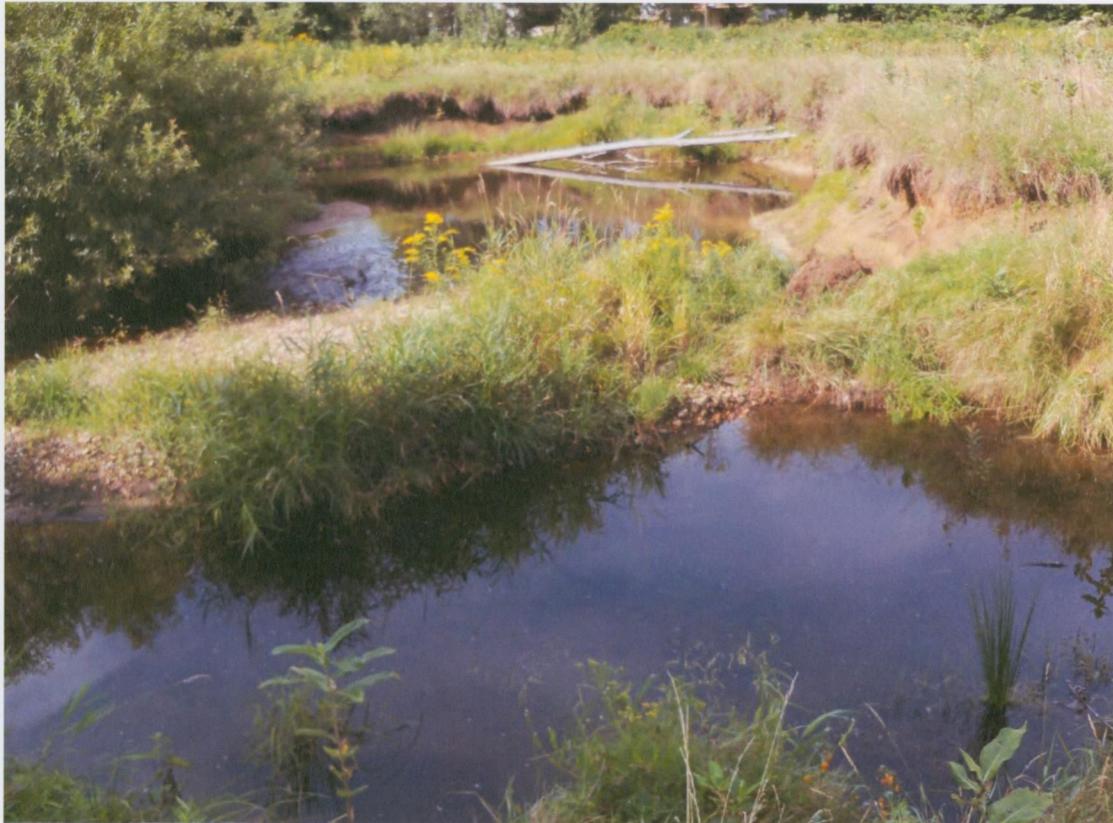
There is a proposed NRCS project (SB4) in segment M01-D project (SB4) that involves streambank stabilization of a bank that is experiencing significant erosion (Figure 8.6). The river is currently in an adjustment process that will move it towards a stable or equilibrium condition through erosion and deposition of sediment. If allowed to continue in the current course, the river will eventually create a bankfull bench or floodplain at a lower elevation. It is understandable that the farmer is concerned about losing land in this location. If the farmer is amenable, a wide buffer of land could be taken out of production and the farmer could be compensated for this additional land through the CREP program. Problems associated with riprapping this section include loss of aquatic habitat, increased energy and erosion downstream of the riprapped section and loss of floodplain access. If the landowner and NRCS decide to move forward with riprapping the bank, a biotechnical approach is recommended. A biotechnical approach may include grading the upper bank and planting with trees as well as incorporating live cuttings such as willow into the rock toe.

Figure 8.6. Bank erosion (looking upstream) along Segment M01-D at proposed NRCS project SB4

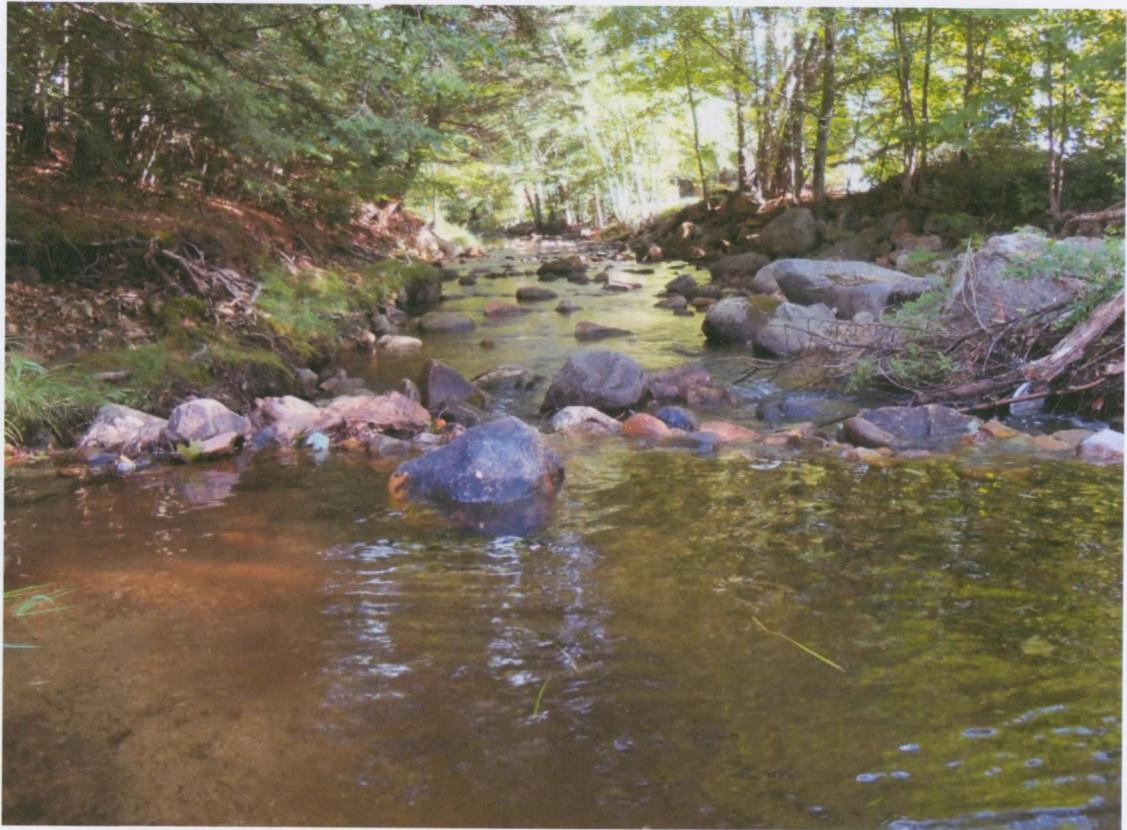
Figure 8.7. Segment M01-E just downstream of Henderson Road crossing with abundant riprap on east bank.

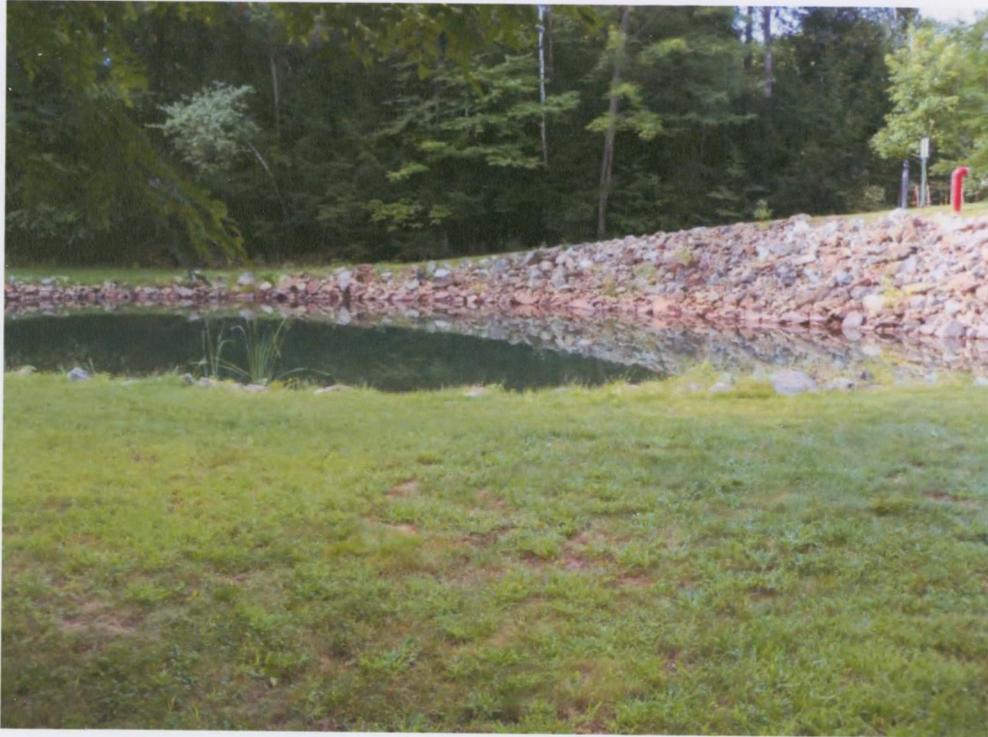
In the center of M01-E, there is a stormwater retention pond in the western side of the river corridor (Figure 8.8). The retention pond is helping to alleviate the impact of stormwater drainage from the nearby development into Gunstock Brook. However, the buffer vegetation within the vicinity of the stormwater pond is predominantly herbaceous, which does not provide the best riparian condition. Approximately 180 feet downstream of the pond is another stormwater input that is causing localized erosion on the western stream bank, which is contributing sediment to the channel (Figure 8.9). It is recommended that the stormwater runoff in this location be improved to alleviate further sediment contribution to the channel (Project #4).

Figure 8.8. Stormwater Pond in the river corridor for M01-E.

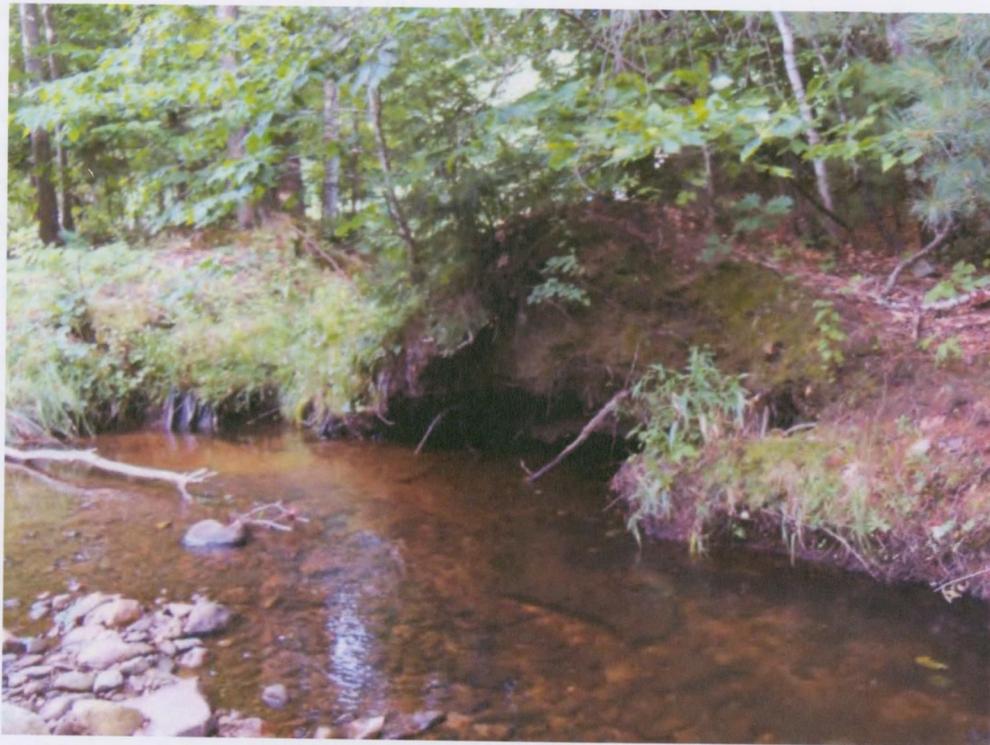
Figure 8.9. Stormwater input causing localized erosion on streambank in M01-E.

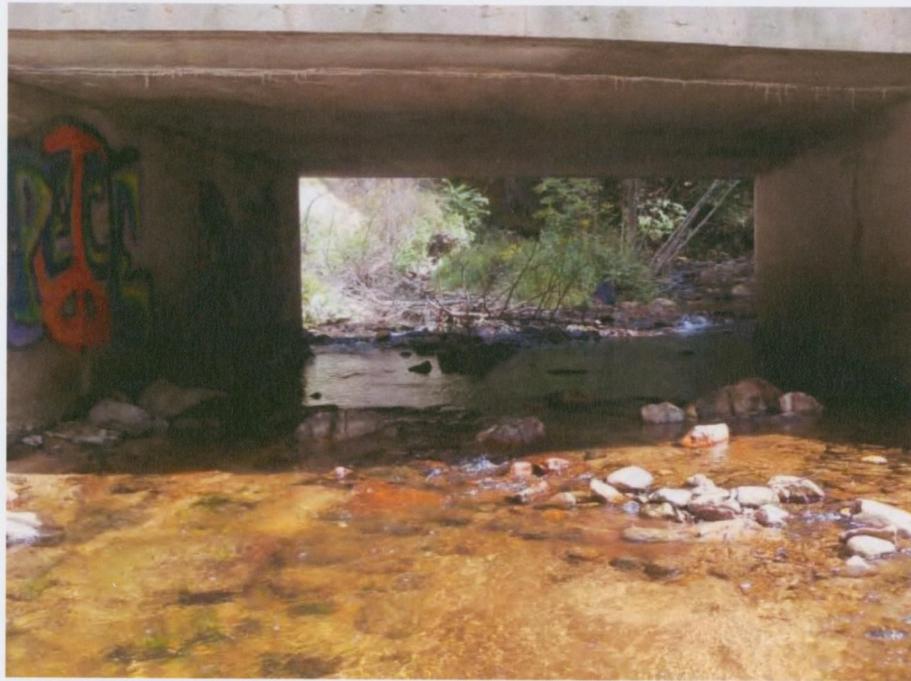
Figure 8.10. Undersized and misaligned Intervale Road Bridge with mid-channel bar upstream in M02-A.

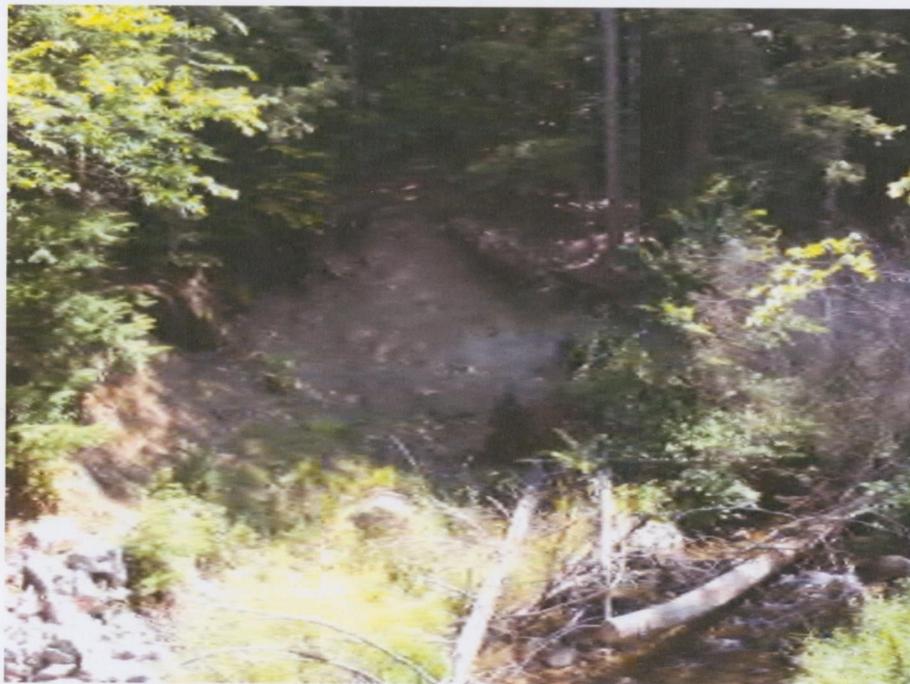
Figure 8.11. Mass failure along eastern bank just upstream of Intervale Road Bridge in M02-A.

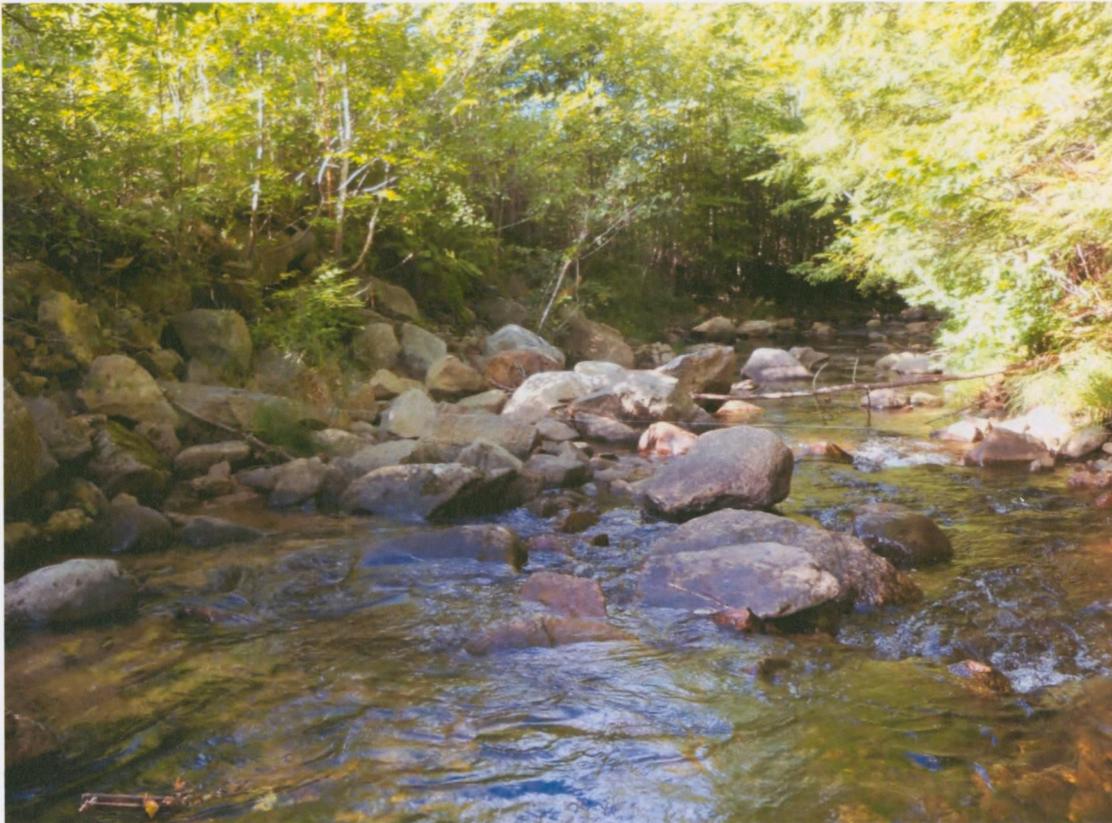
Figure 8.12. Cobble dominated “B” stream type and failing riprap in segment M02-B.

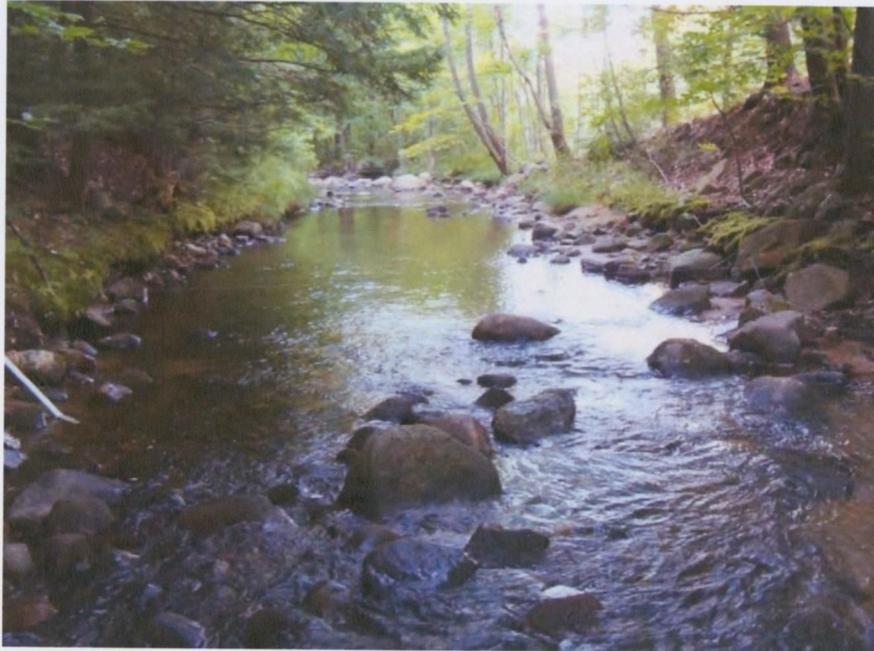
Figure 8.13. Straightening and road encroachment in Segment M02-C.

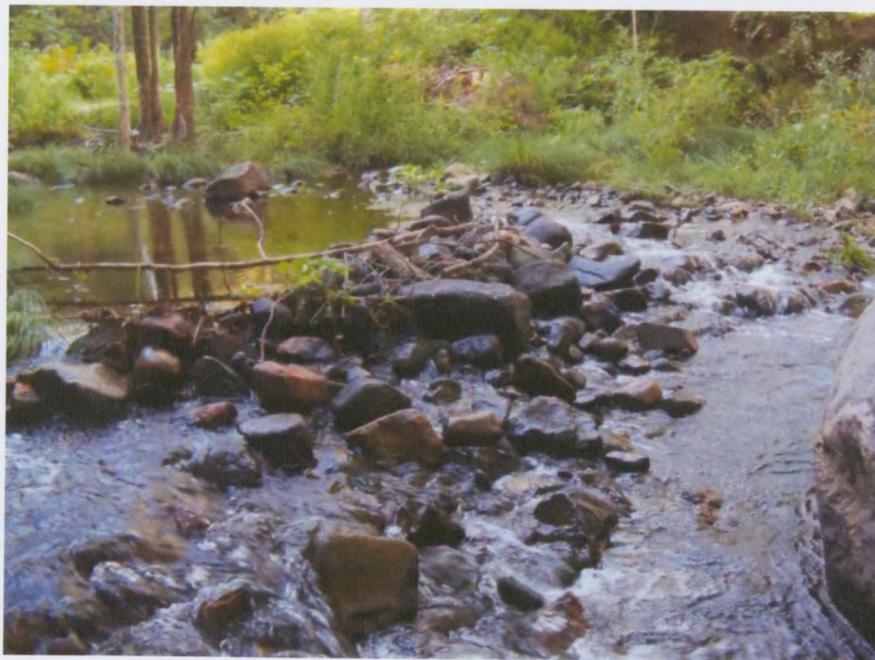
Figure 8.14. Diagonal bar in Segment M02-C.

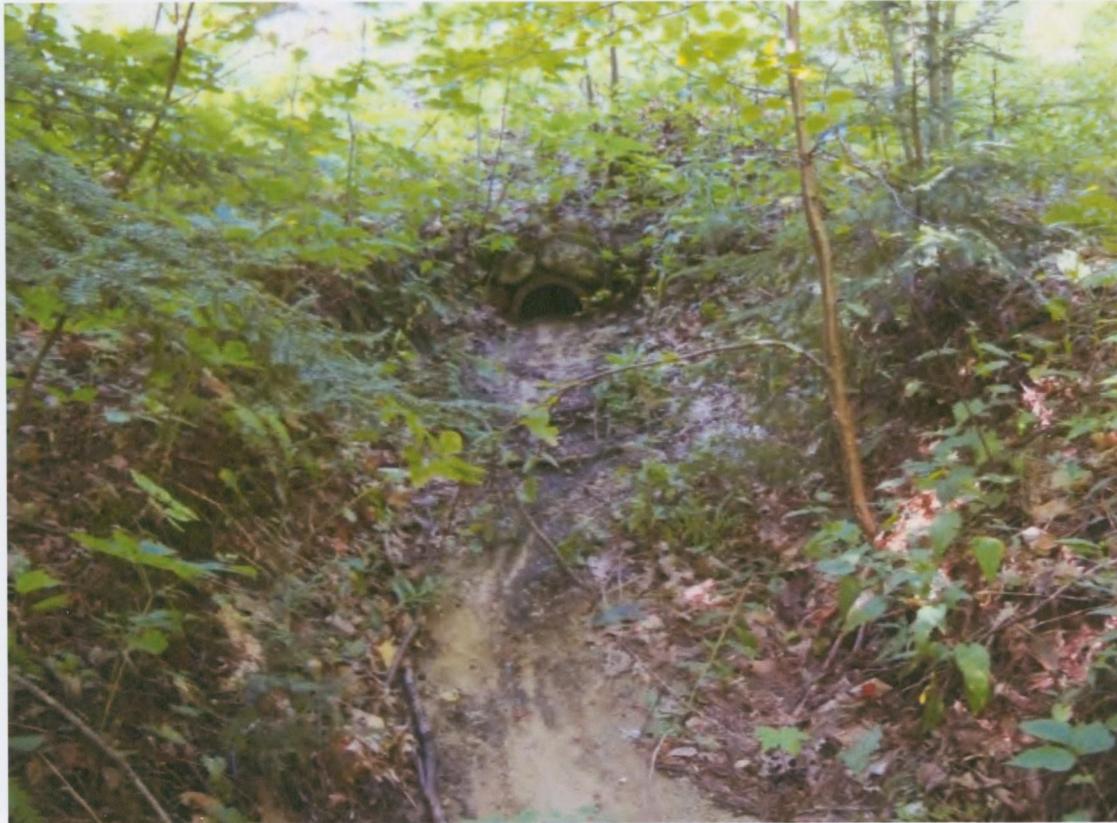
Figure 8.15. Stormwater runoff from Intervale Road into M02-C.

within Segment M02-C. Project #6 addresses improving stormwater runoff from Intervale Road into Gunstock Brook. The two bridges that cross Gunstock Brook in Segment M02-C (Intervale Road and Cherry Valley Road) are both noted as high priority for replacement due to being significantly undersized (Projects #7 and #9).

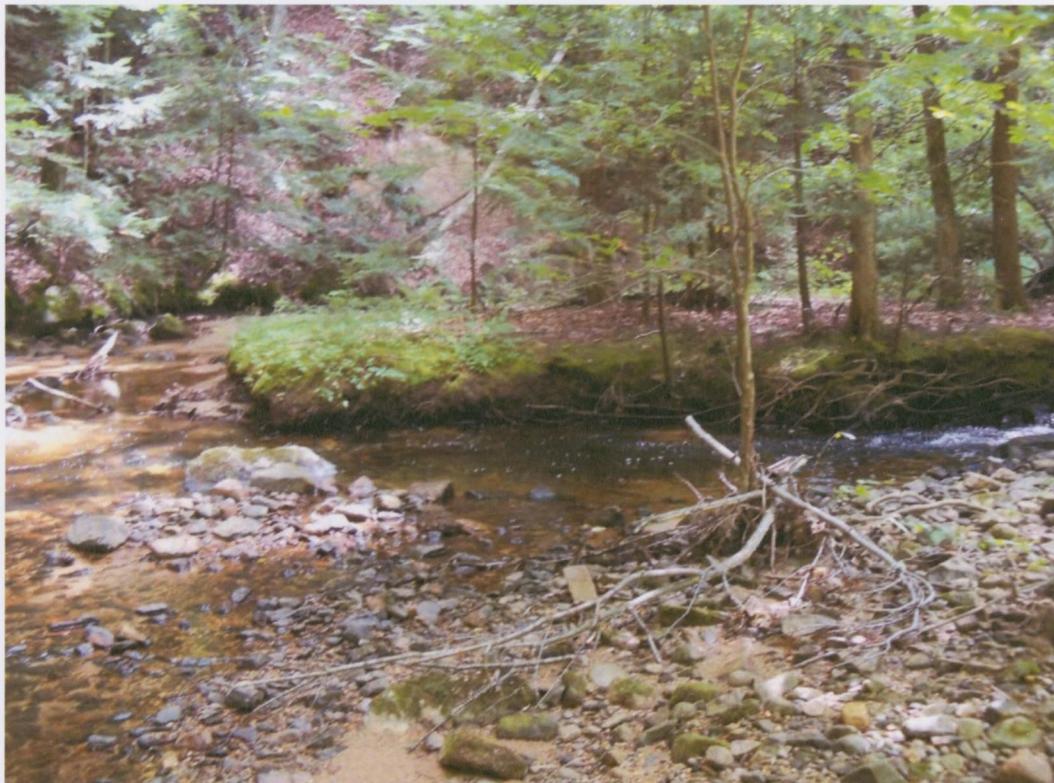
Figure 8.16. Braided section of M03-A.

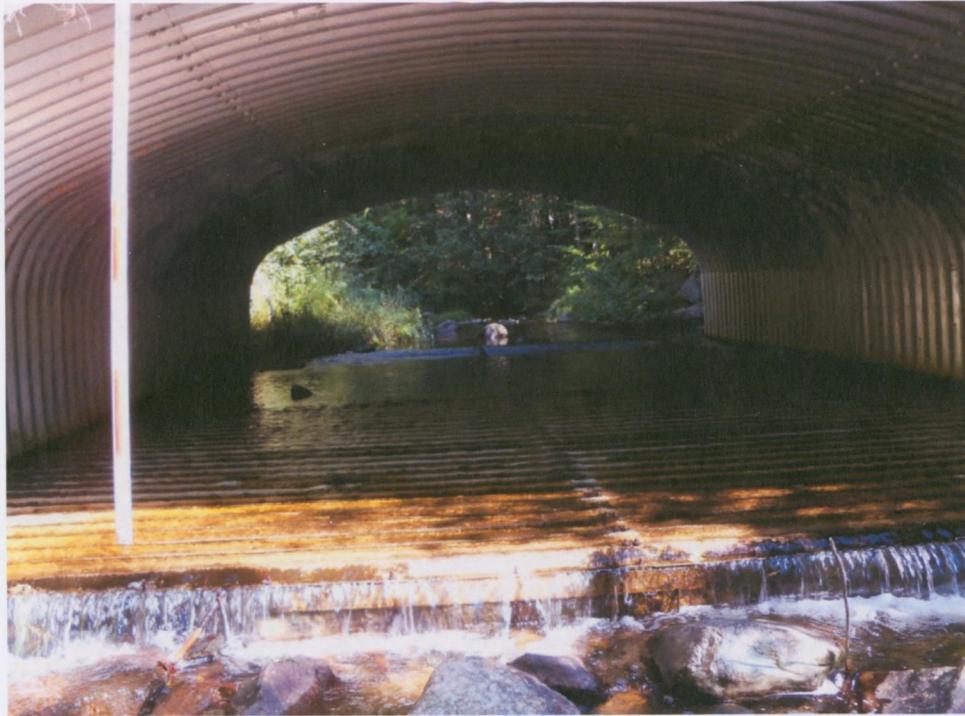
Figure 8.17. Perched culvert at Town Garage Access Road in Segment M03-A impeding aquatic organism passage.

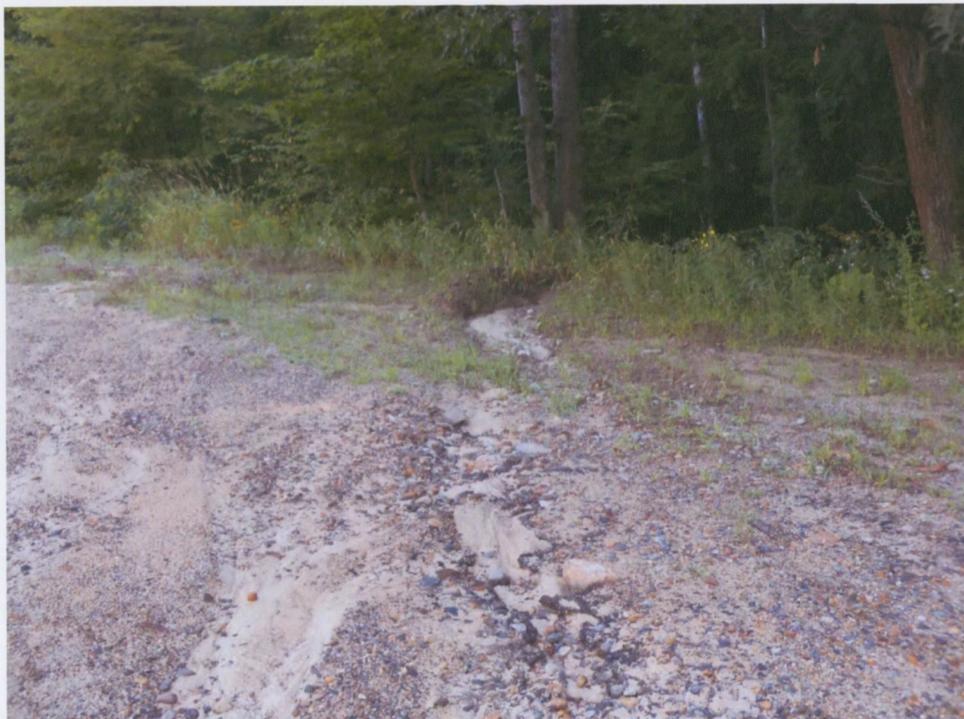
Stormwater runoff from the town garage parking lot is causing excess sediment into Gunstock Brook (Figure 8.18). Project # 11 would address the sediment loading by improving stormwater runoff from the parking area. Another project that would address sediment loading and runoff into Gunstock Brook (M03-A) is an investigation of an eroded swale (Figure 8.19) that is receiving discharge from a well (Project #12). Runoff from the swale is introducing significant sediment into Gunstock Brook (Figure 8.20).

Figure 8.18. Sediment laden stormwater runoff from Town Garage parking lot in M03-A.

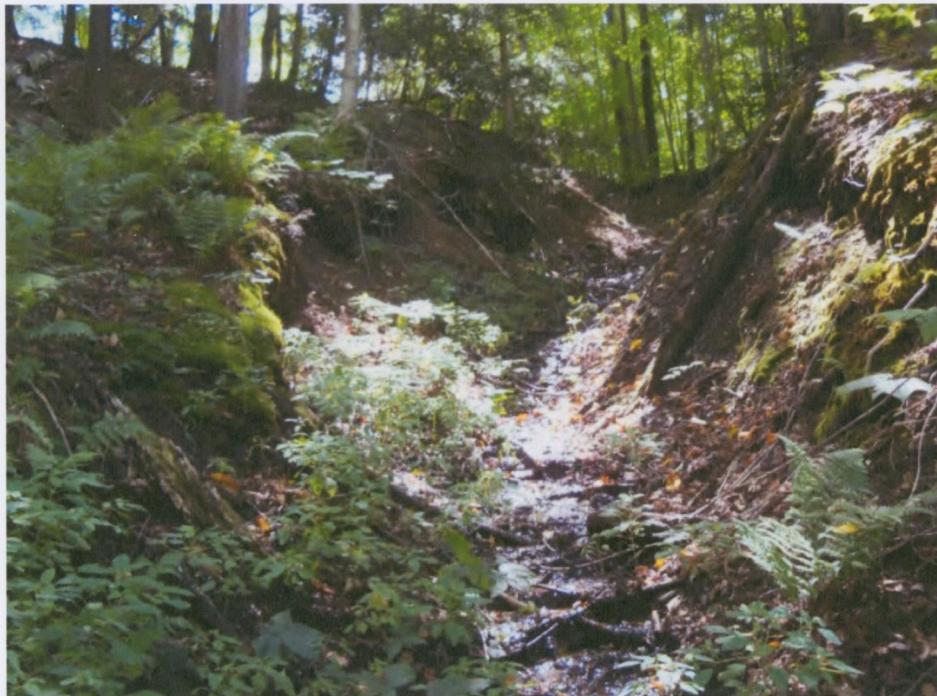
Figure 8.19. Eroded swale in Segment M03-A.

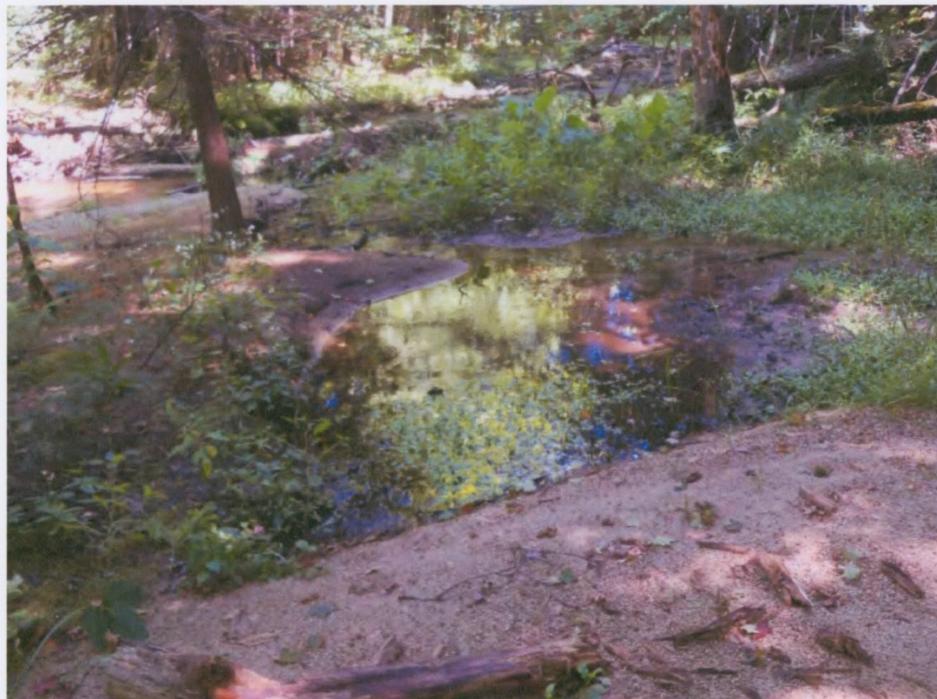
Figure 8.20. Sediment from eroded swale in Segment M03-A.

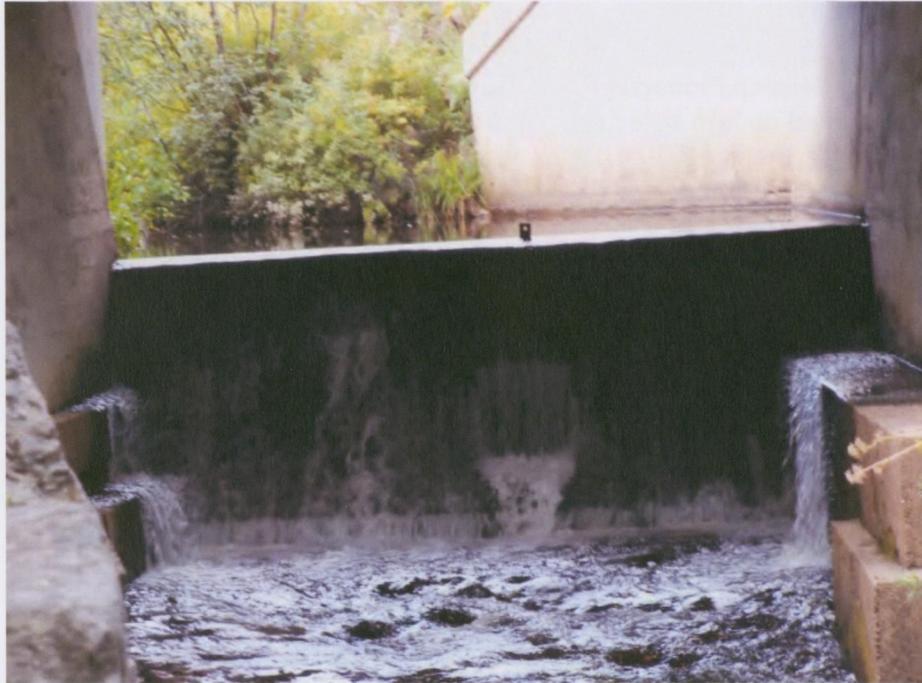
Figure 8.22. Dam at Belknap Mountain Road crossing in M03-B.

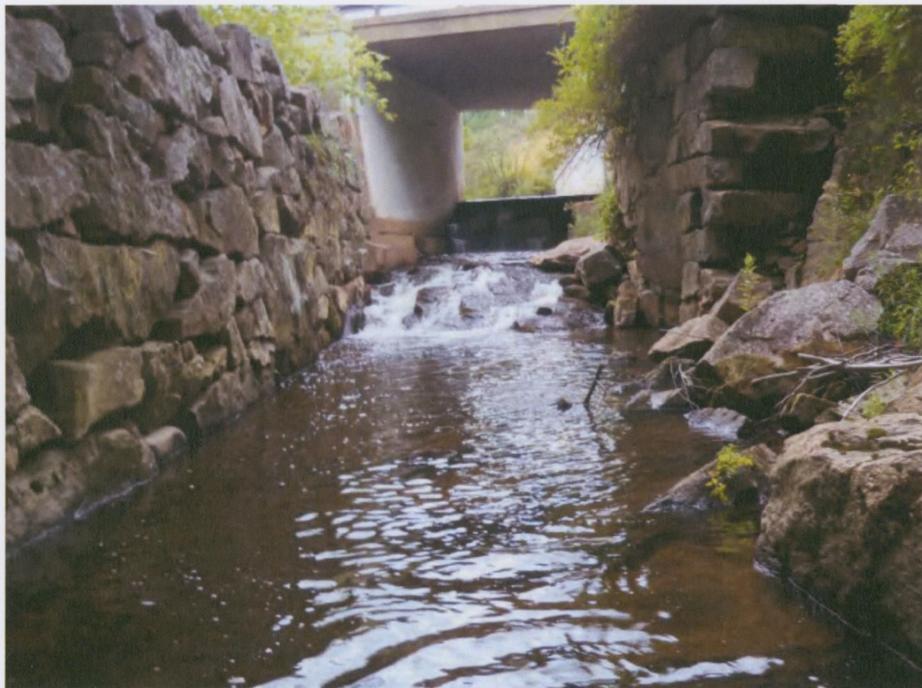
The dam under Belknap Mountain Road is impeding the passage of aquatic organisms. Downstream from the dam are rock walls lining the stream banks (Figure 8.23). The dam and rock walls are what is left of a sawmill that operated in the 1800s (Gilford Historic District Commission, 1990). During this time period, the dam impounded water up into Reach M04. The recreational area was called the Millpond and was used as a fishing and ice skating spot. Now the area contains tennis courts. An alternatives analysis is recommended to improve habitat connectivity at the former mill site and determine if it is feasible and beneficial to remove the dam and rock walls (Project #13). Historic preservation may be a consideration regarding removal of this dam.

Figure 8.23. Rock walls downstream of the Belknap Mountain Road crossing in M03-B.

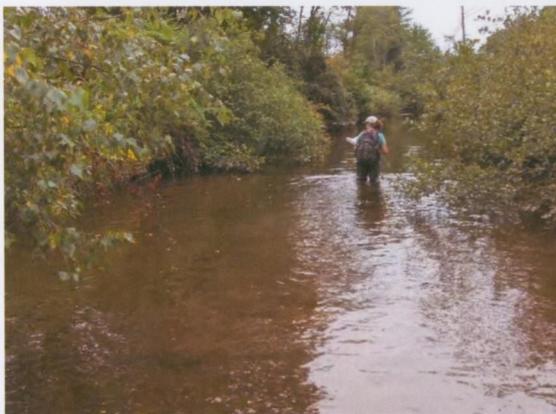
Figure 8.24. Straightened section of M04-A.

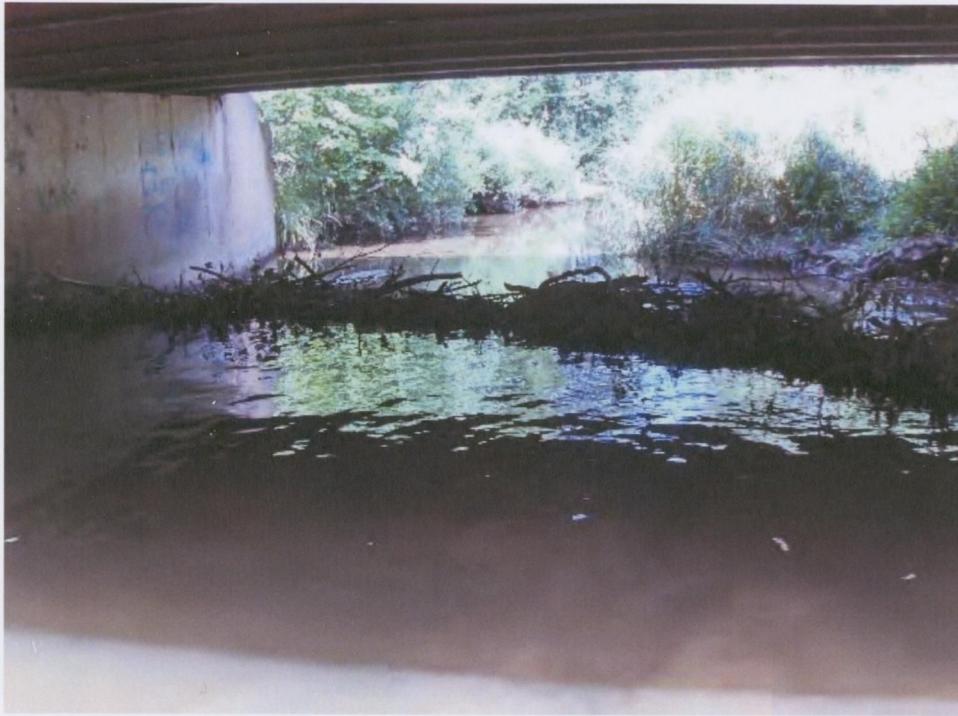
Figure 8.26. Beaver dam within Alvah Wilson Road Bridge in M04-A.

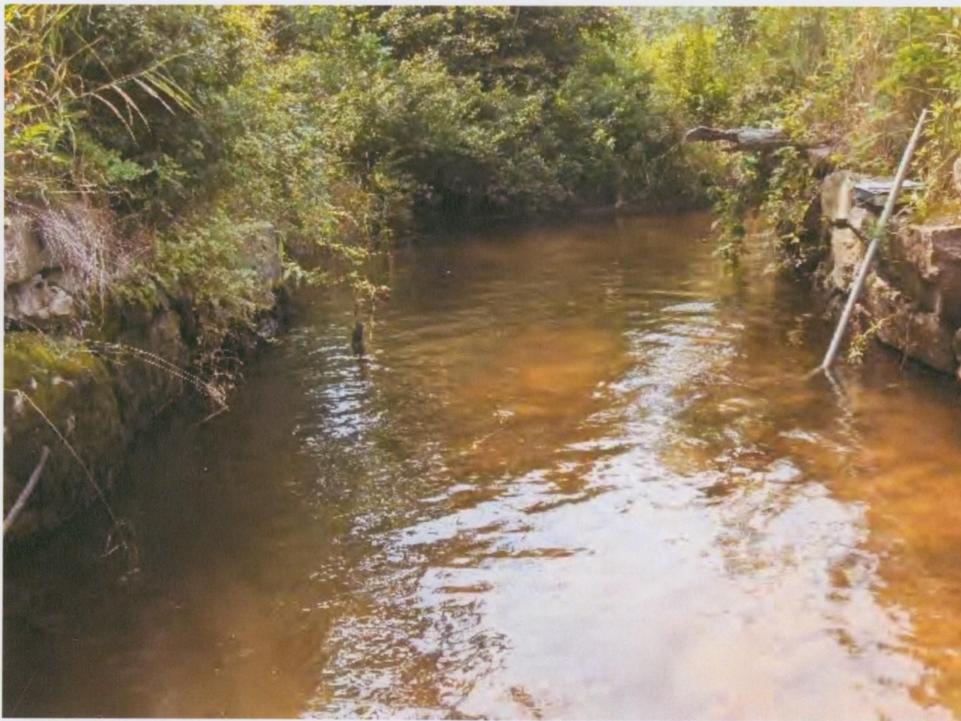
Approximately halfway through the segment heading upstream, Gunstock Brook flows past the Alvah Wilson Middle School and then continues under Alvah Wilson Road Bridge. There is currently a beaver dam within the structure that may cause some problems in the future for stream flow through the bridge (Figure 8.26). There are also two old abutments within M04-A which are constricting the stream channel. One abutment is in the downstream straightened section, but another one is located approximately 850 feet from the top of the segment (Figure 8.27).

Figure 8.27. Old abutment constricting the stream channel in M04-A.

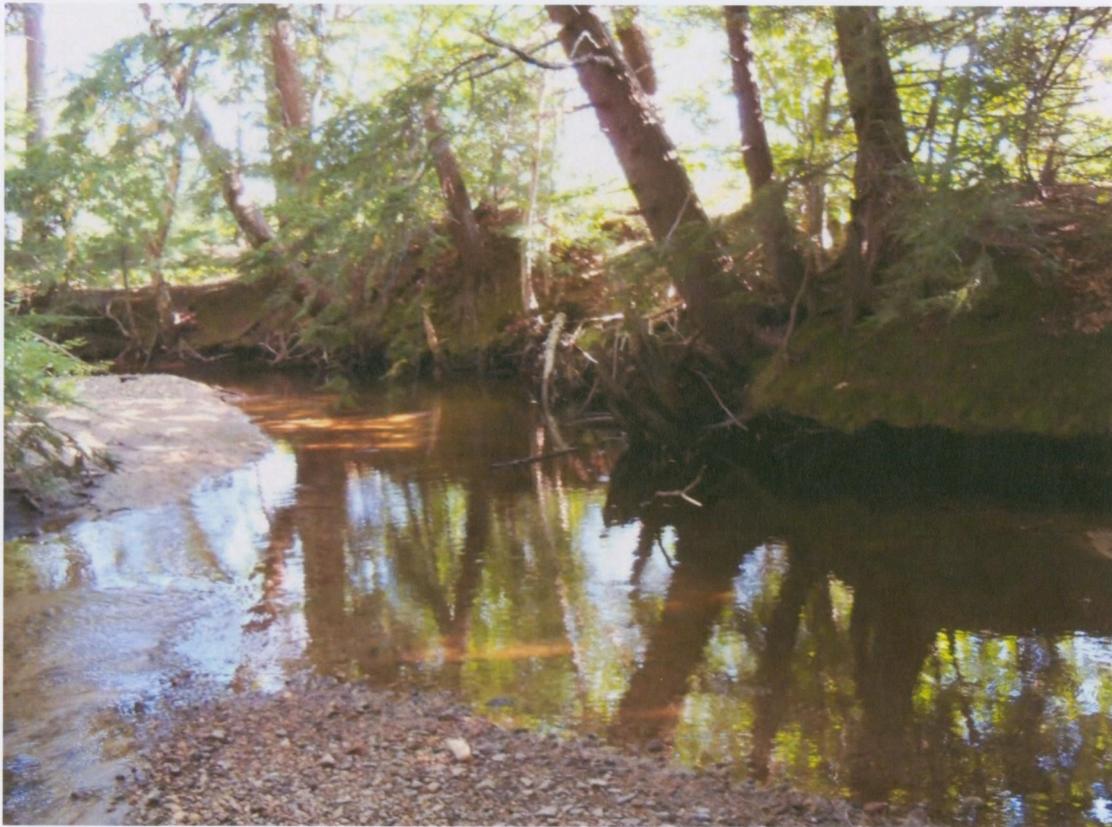
Figure 8.28. Moss covered undercut bank in M04-B.

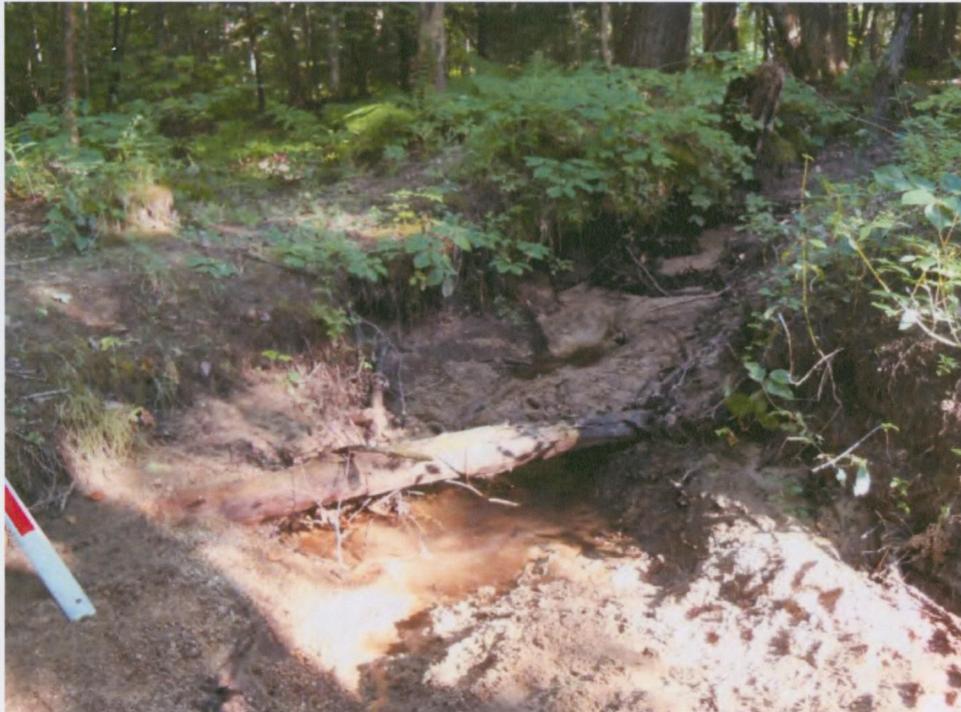
Figure 8.29. Tributary contributing sediment to Gunstock Brook in Segment. M04-B.

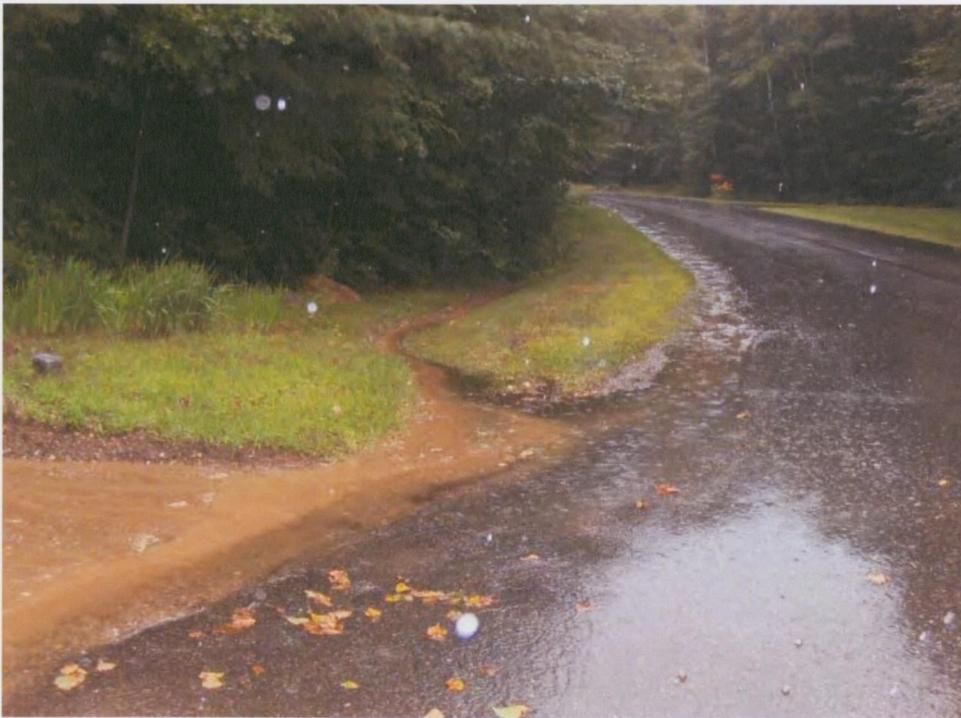
Figure 8.30. Turbid stormwater runoff on Doris Drive on August 21, 2012.
