Gunstock Brook Watershed Stream Geomorphic Assessment Gilford, New Hampshire July 9, 2012

Prepared by:
Bear Creek Environmental, LLC
297 East Bear Swamp Road
Middlesex, Vermont 05602

Prepared under contract to:
Belknap County Conservation District
2 Airport Road, Unit #1
Gilford, NH 03249

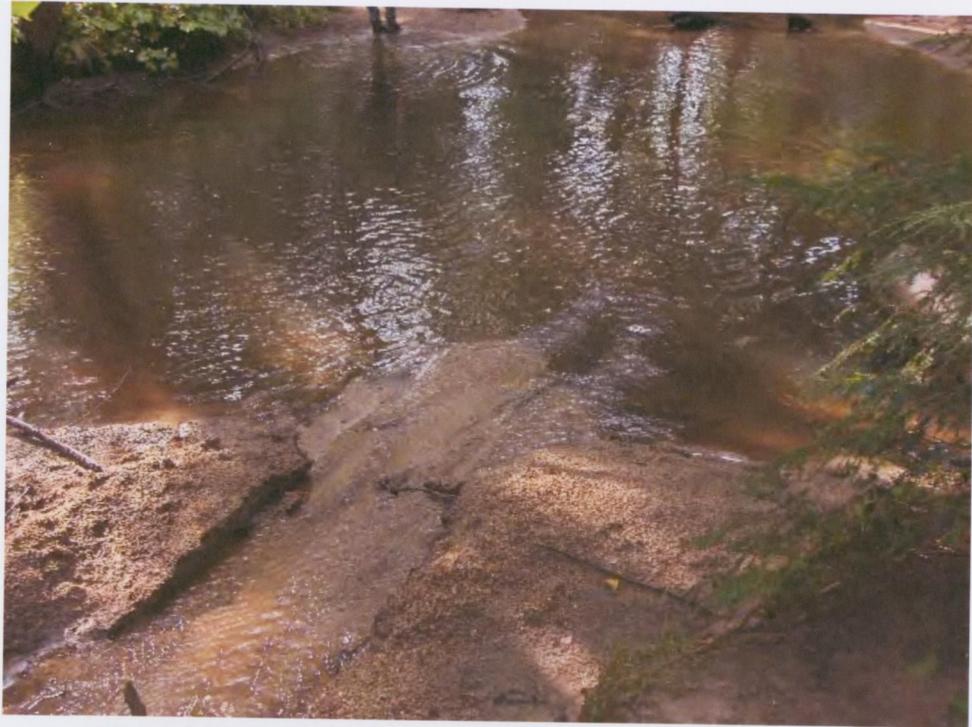
Figure 8.31. Sediment loading from sandy tributary into M04-B.

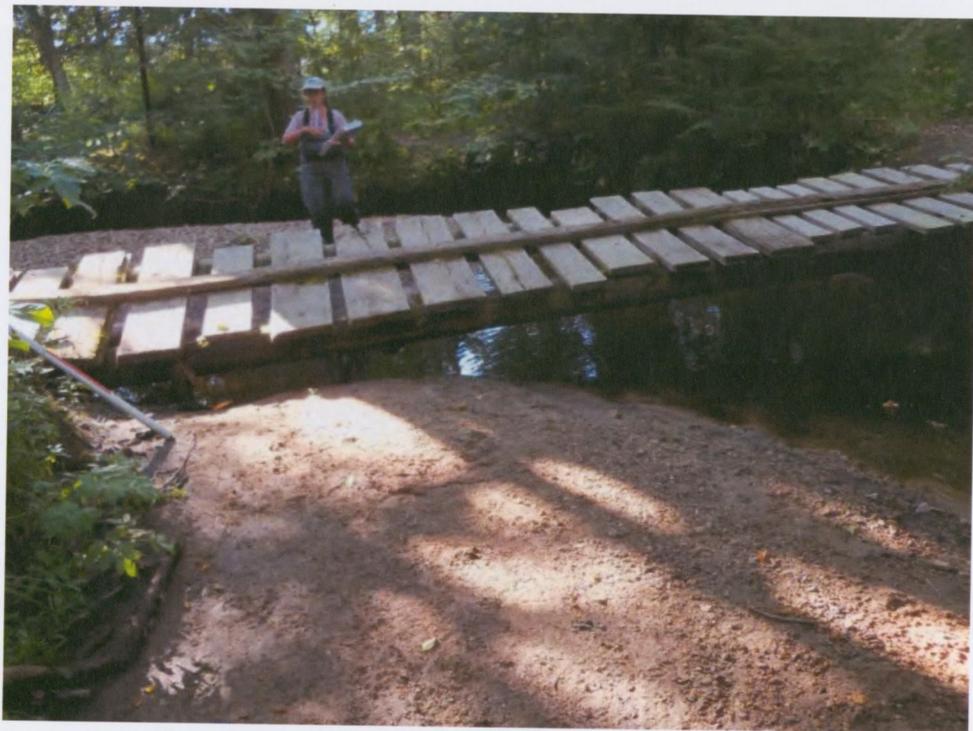
A wooden bridge along Gunstock Brook is currently collapsing (Figure 8.32). Sediment and debris are blocking the bridge that does not appear to be in use. Removal of the bridge is recommended (Project #15).

Figure 8.32. Collapsing wooden bridge in M04-B.

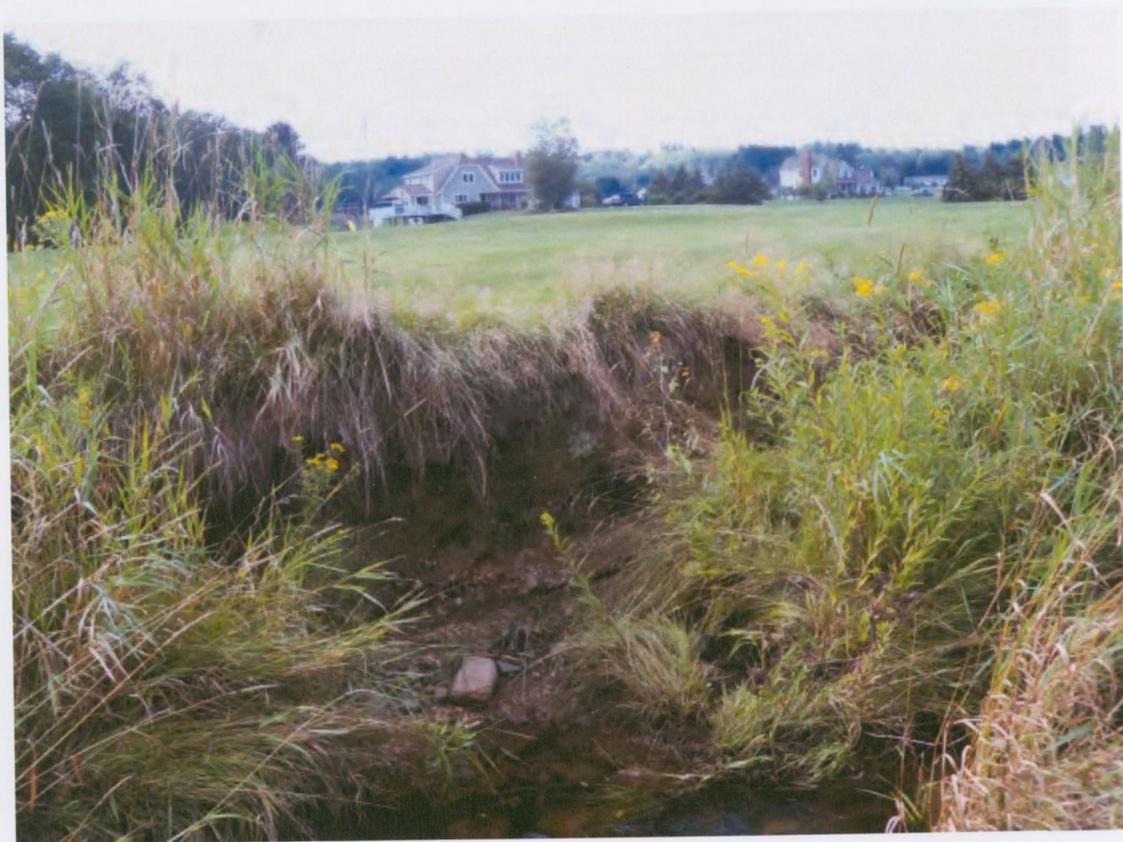
Figure 8.33. Lack of riparian buffer and streambank erosion in M04-C.

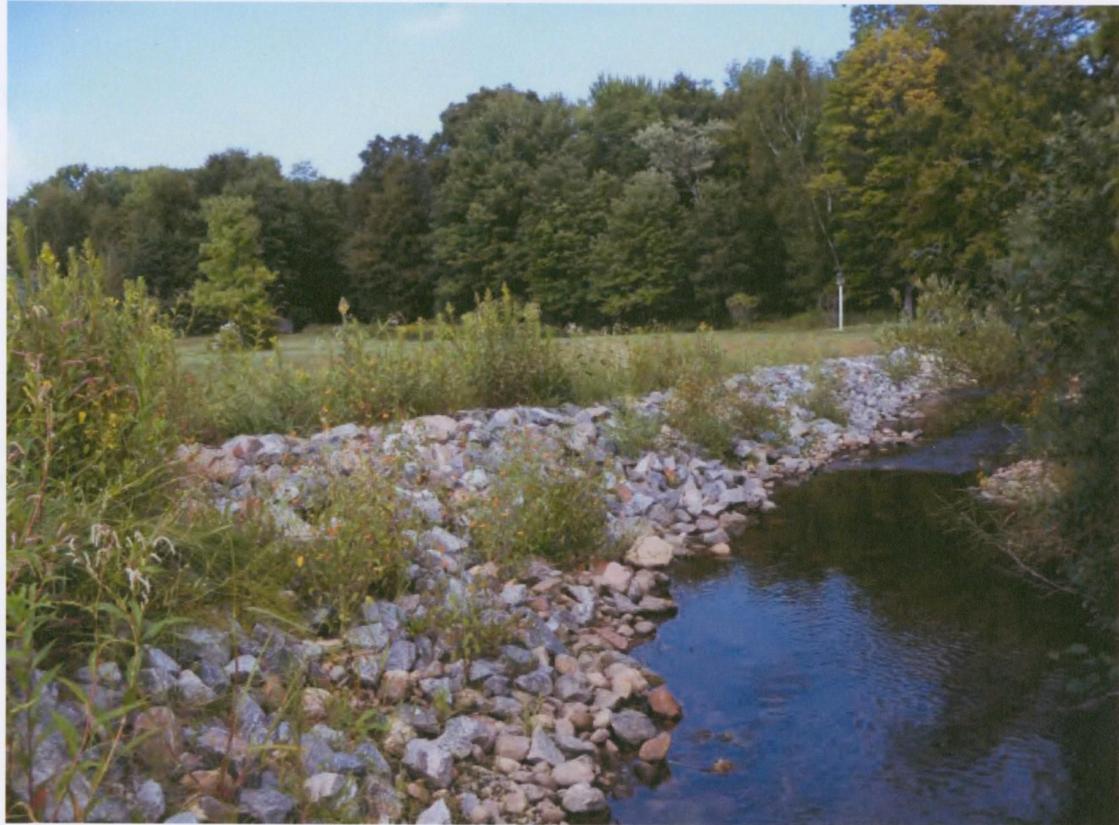
Figure 8.34. Channel alteration and streambank armoring in M04-C.

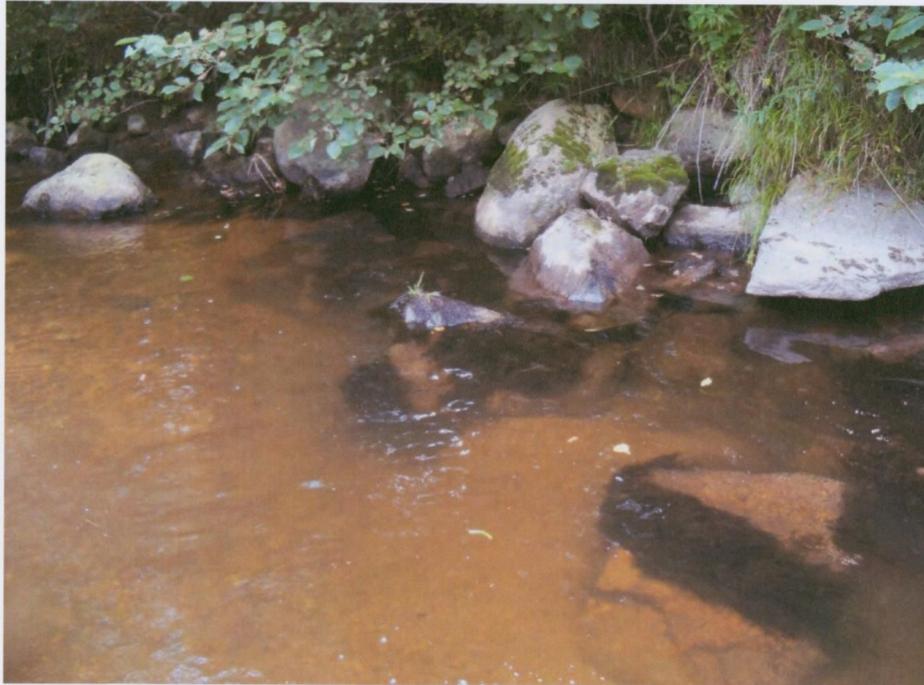
Figure 8.36. Failing rip-rap in M05-B.

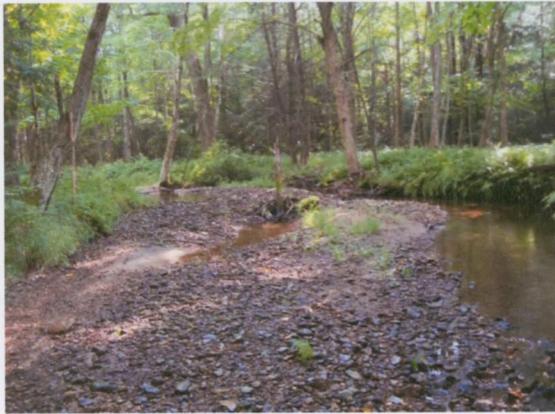
Figure 8.37. Large diagonal bar showing major aggradation in M05-C.

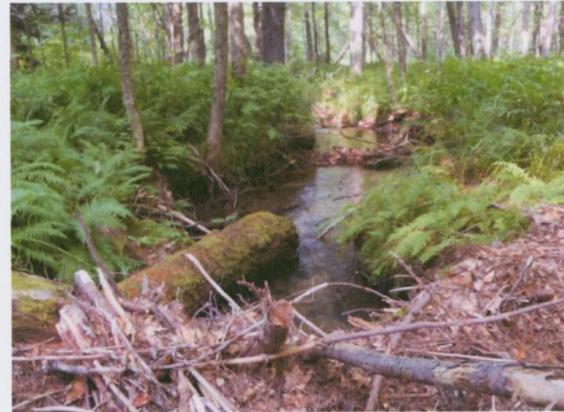
Figure 8.38. Channel avulsion indicating major planform change in M05-C.

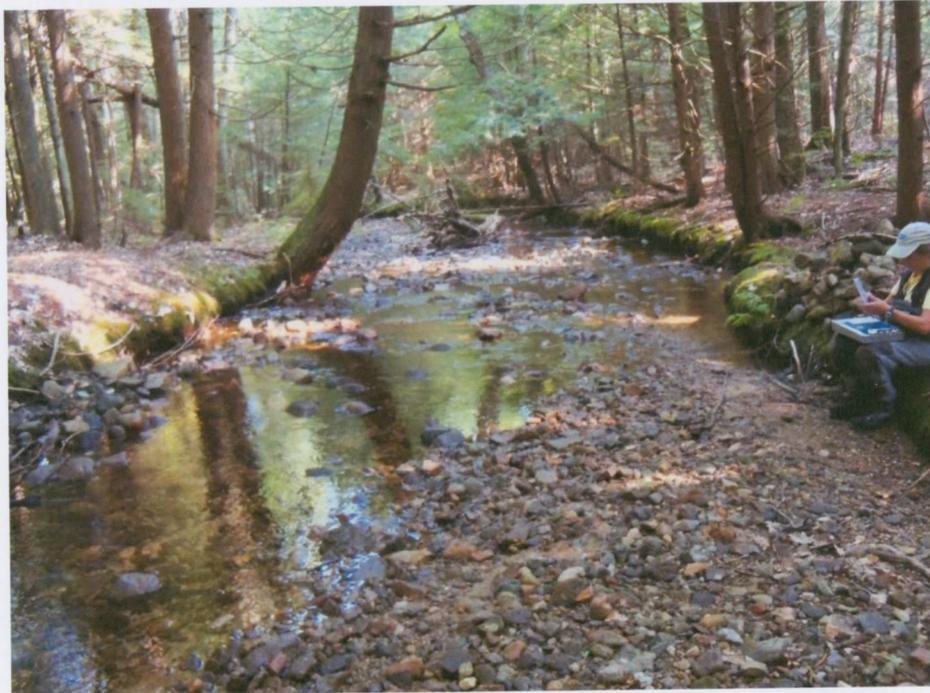
Figure 8.40. Depositional features in T2.01-A caused by drop in slope and perhaps upstream sediment source.

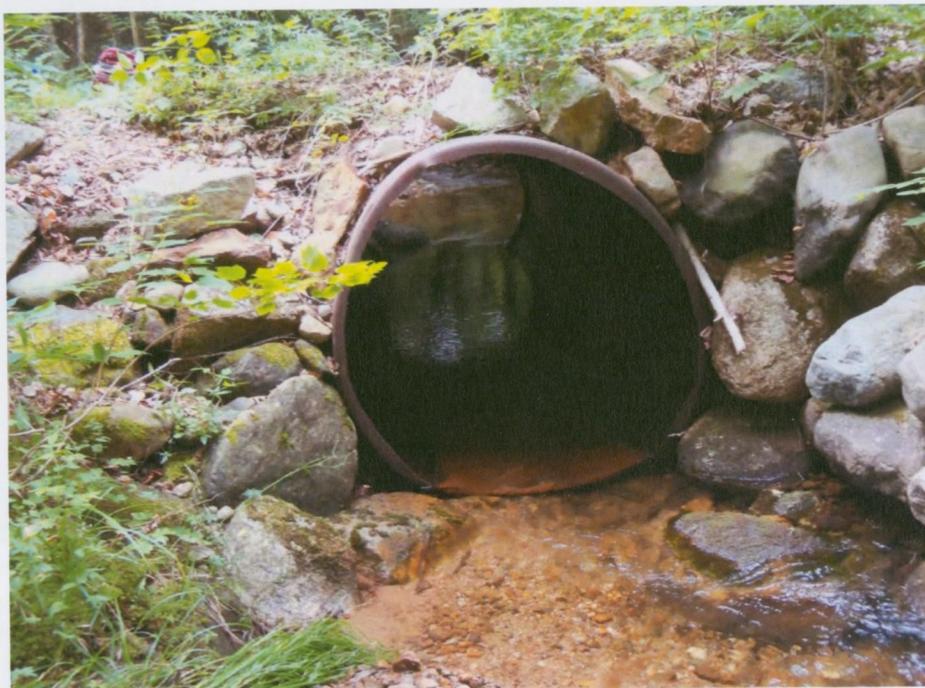
There is one stream crossing in T2.01-A that is significantly undersized and causing geomorphic instability. A culvert at a trail crossing (Figure 8.41) is in poor condition (rusty bottom and deformed) and has been given a high priority for replacement (Project #19) due to its reduced aquatic organism passage and geomorphic incompatibility. The replacement of this undersized structure is also a recommendation of NRCS (see page 51).

Figure 8.41. Undersized and rusted culvert in T2.01-A.
