THE BENJAMIN ROWE HOUSE
COMMITTEE REPORT
AUGUST 1991

Arthur Tilton, chairman
Kathy Francke
Gilford School Board
Pat LaBonte, selectman
Adair Mulligan

On 2 June 1989, the Selectmen established a committee to study the future of the then named Alvah Wilson House. The following findings and recommendations are the result of the committee's works to fulfill the goals and objectives adopted at that time.

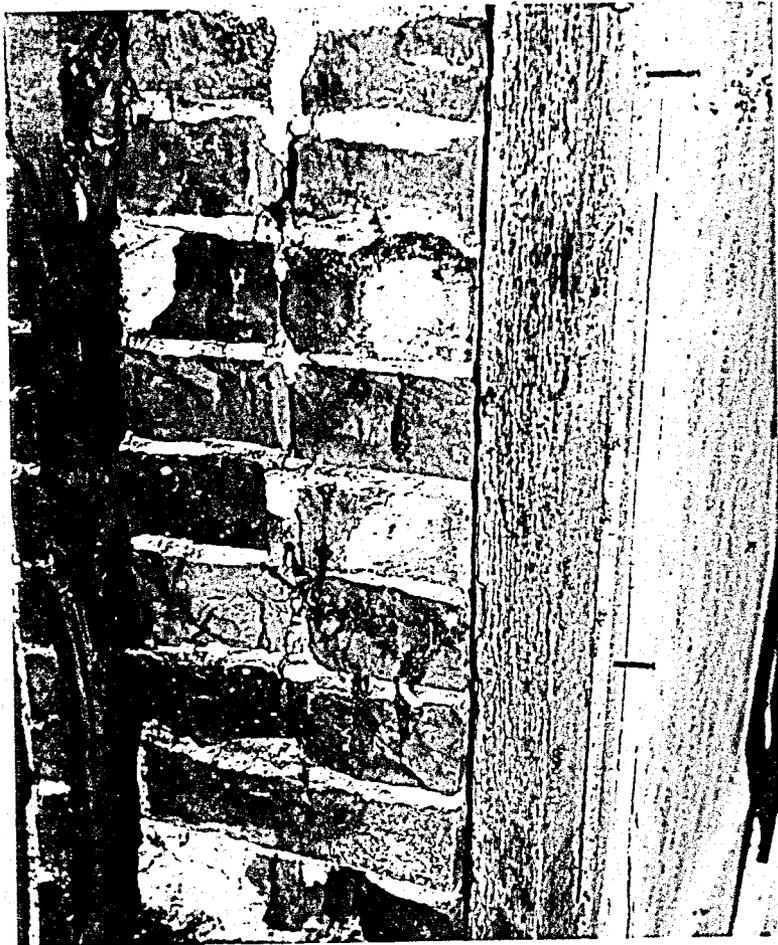
Illus. 6.

Chiseled brick
of
original
window

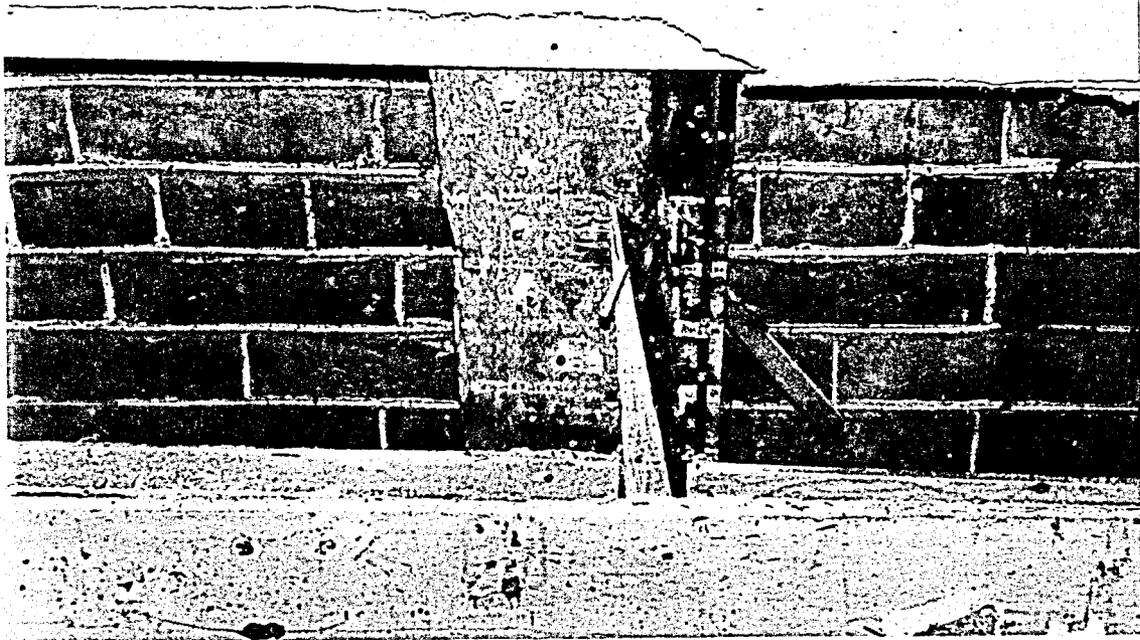
Illus. 7. Brick end wall

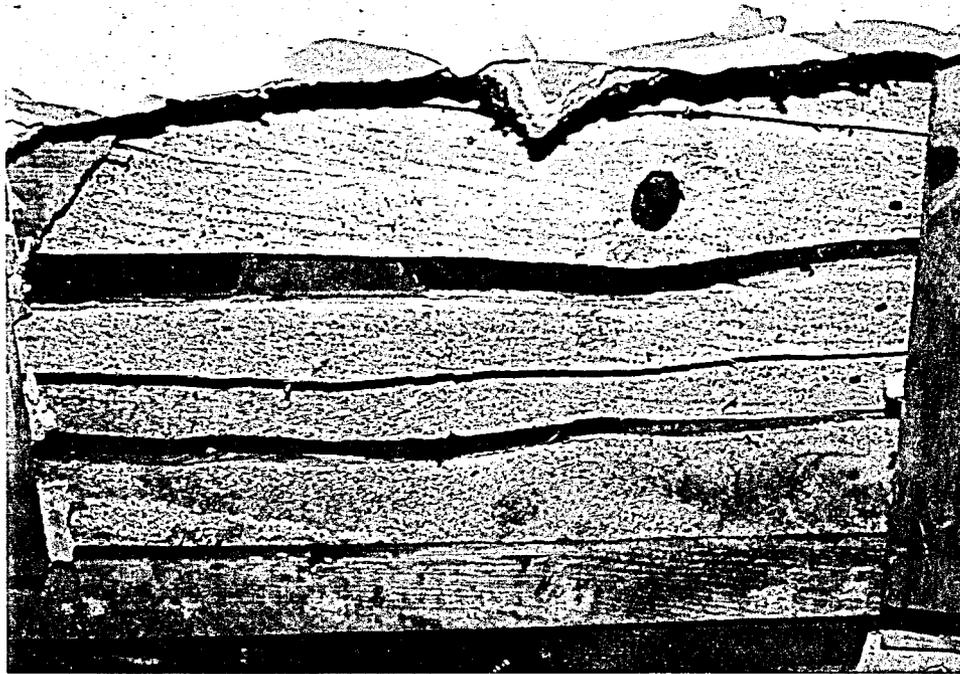
Illus. 11

A further question remains about the chimney of the ell: there is every indication that it was a later addition. It is of cinderblock construction, none of the chimney area is appropriately framed; neither in the basement, nor as it passes through to the second floor. The original, mysterious, riven lath of the first floor ceiling had been sawn through, and no support was provided the lath, causing major plaster and lath failure in the area of the chimney. (Illus. 11-13)

Riven lath of 1st floor ceiling

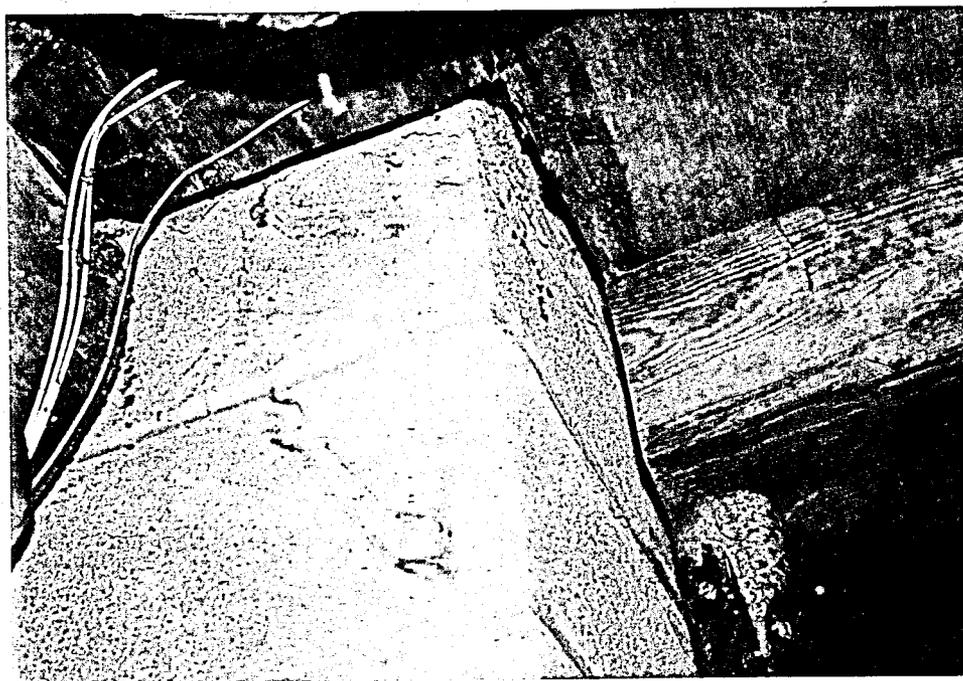
Illus. 12

Chimney from basement to first floor

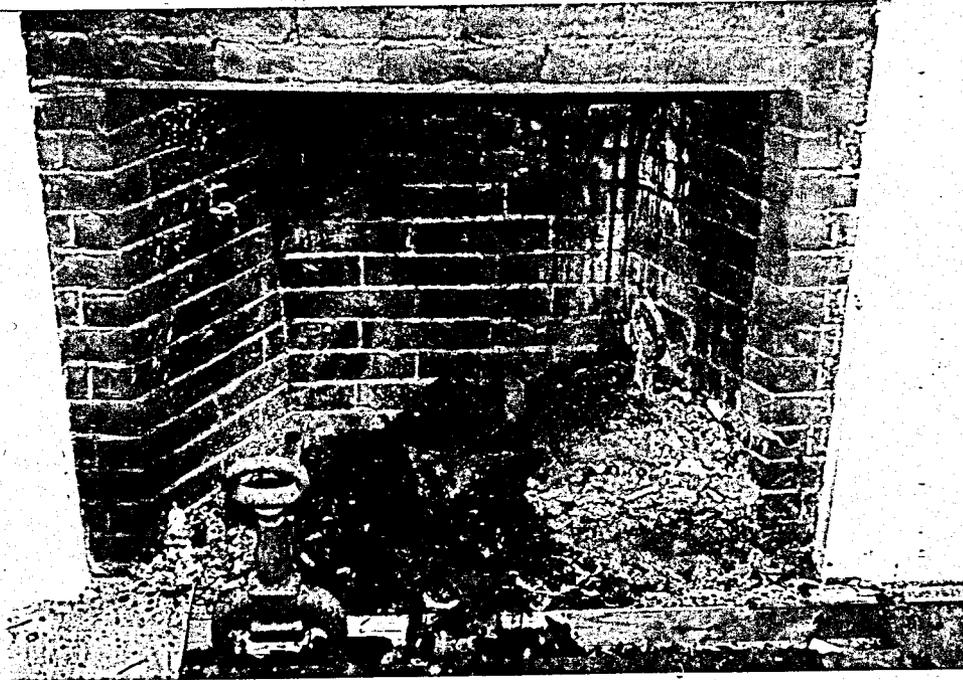
Illus.14

Except for the replaced windows, entry doors, kitchen area, and added bathroom, the first floor of the brick house is substantially intact. Although every chimney was modified to accomodate wood or coal stoves, the placement and surrounds of three remain unaltered. One fireplace, in the northwest room, was sealed in 1954, as evidenced by a New York Times page from December 8, 1954 found stuffed in the flue opening. Andirons were also in the fireplace. (Illus. 14)

Northwest fireplace

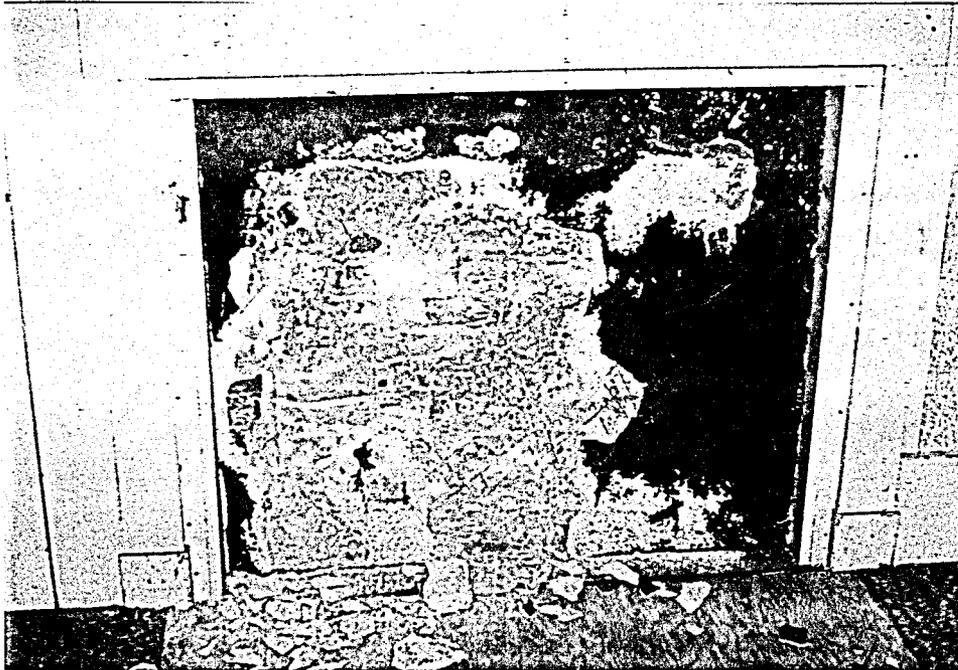
The fireplace opening in the southwest room was bricked, plastered, painted, and later plywooded over; its hearth had been removed. (Illus. 15)

Illus. 15 *Southwest fireplace*

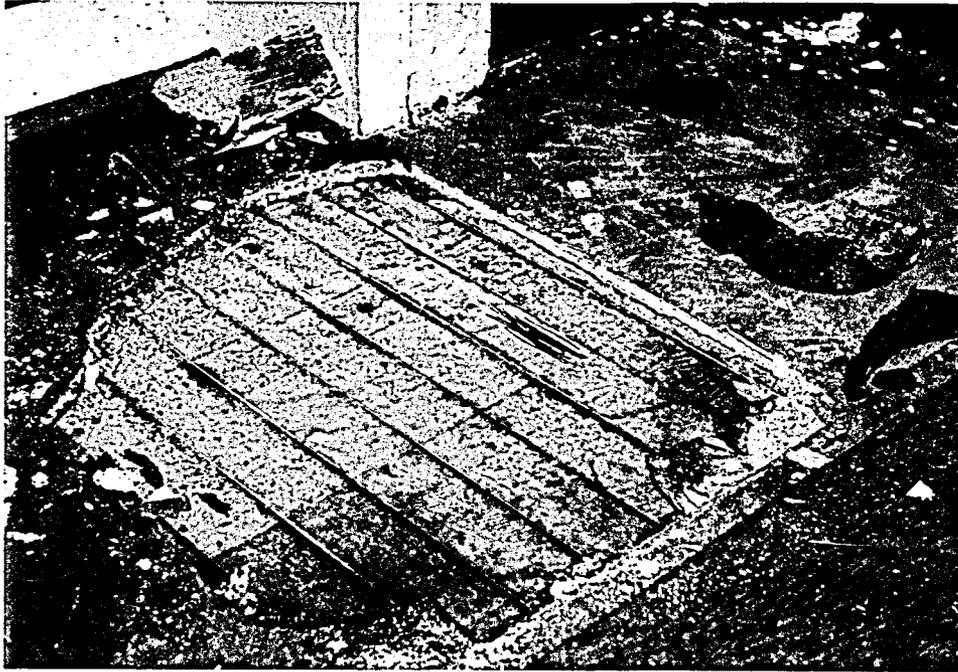
The fireplace in the southeast room remains open, complete with exposed hearth; but it, too, shows evidence of a later stovepipe access. The northwest fireplace, in the former kitchen, has been totally removed, and replaced with a chimney to accommodate a stove. Removal of the carpeting in this area revealed a narrow board maple floor which replaced the original flooring as well as the former hearth. The material is consistent with early 20th century kitchen "remodelings" of the area. (Illus. 16)

(Illus. 16) Northeast ("kitchen")-fireplace area

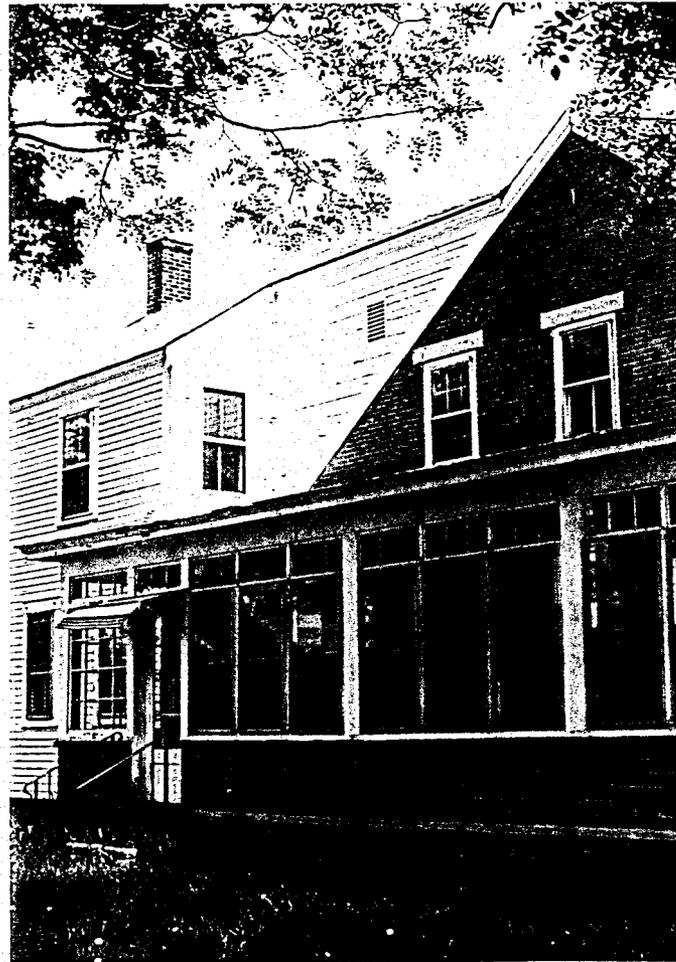
Illus. 21

The junction of the brick house and the wooden ell revealed possibly an "unfinished" attic room due to the plasterwork, evidence of a doorway, and containing the only original 6 over 6 window of the entire second floor. (Illus. 21,22)

Only 6/6 window
on second floor.

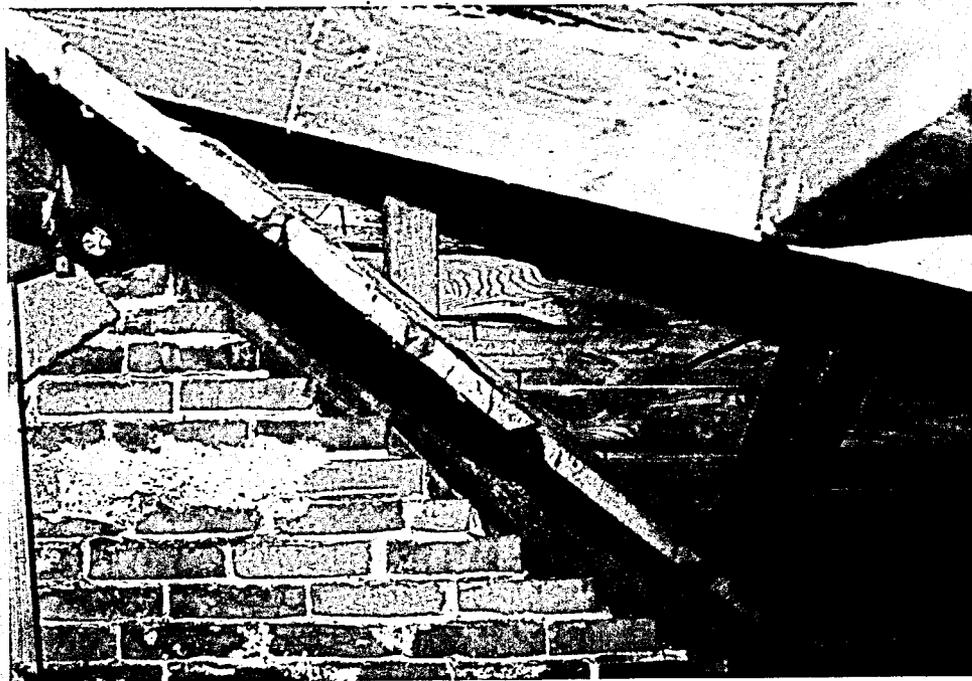
Illus. 26

- 23 - *Original planking ↗ end wall*

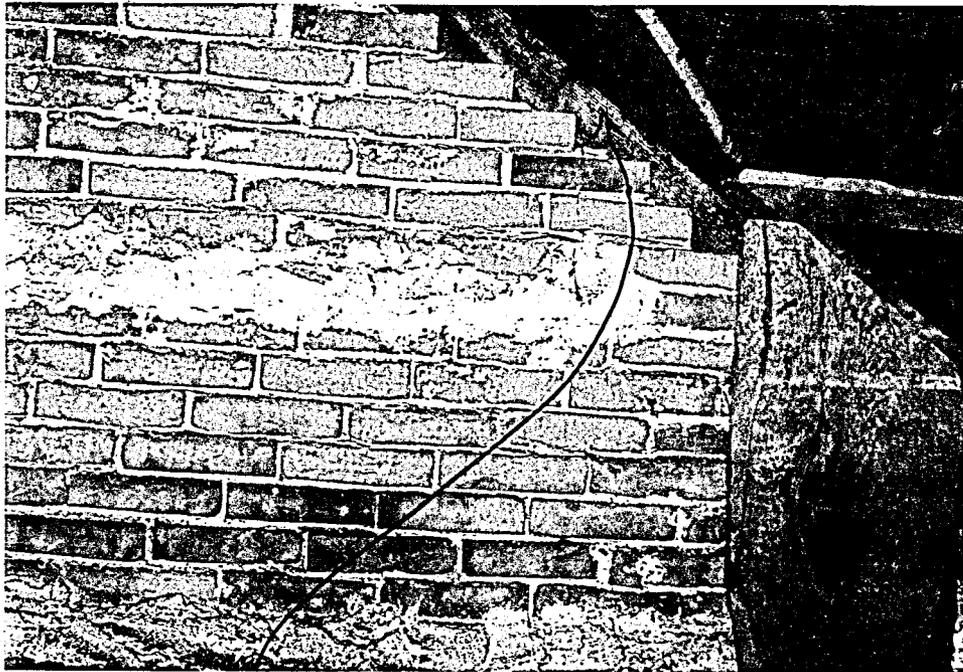
Illus. 27

→ slope of original roof.

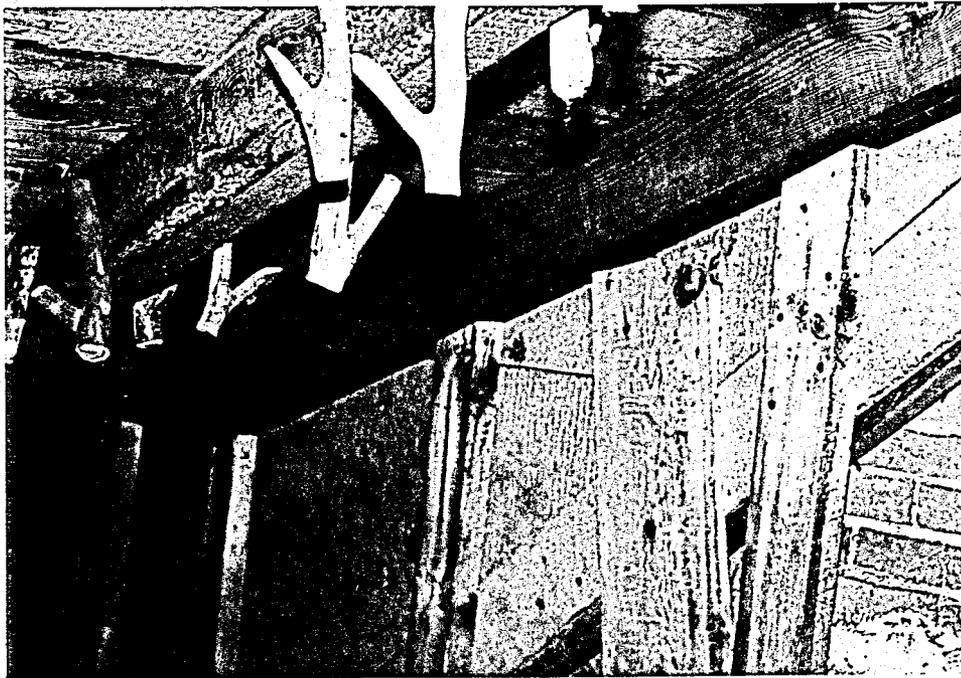
Illus. 32

A final charismatic note of dormer intrigues was the presence of what is assumed to be "drying pegs": wooden hooks hung along the rafters, made from branch crotches in the tradition described by Eric Sloane. (Illus. 31,32)

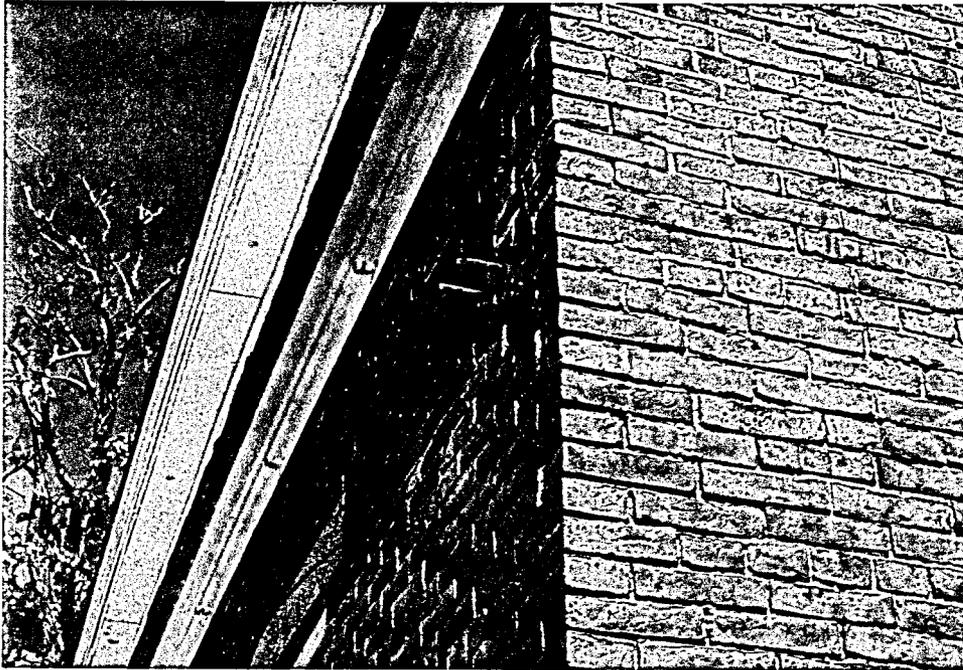
Illus. 34

Finally, the presence of wrought iron brackets on the south and north face of the house attest to the previous presence of drains and down-spouts for the original structure. (Illus. 34)

→ Downspout support.
