Gunstock Brook Watershed Stream Geomorphic Assessment Gilford, New Hampshire July 9, 2012

Prepared by:
Bear Creek Environmental, LLC
297 East Bear Swamp Road
Middlesex, Vermont 05602

Prepared under contract to:
Belknap County Conservation District
2 Airport Road, Unit #1
Gilford, NH 03249

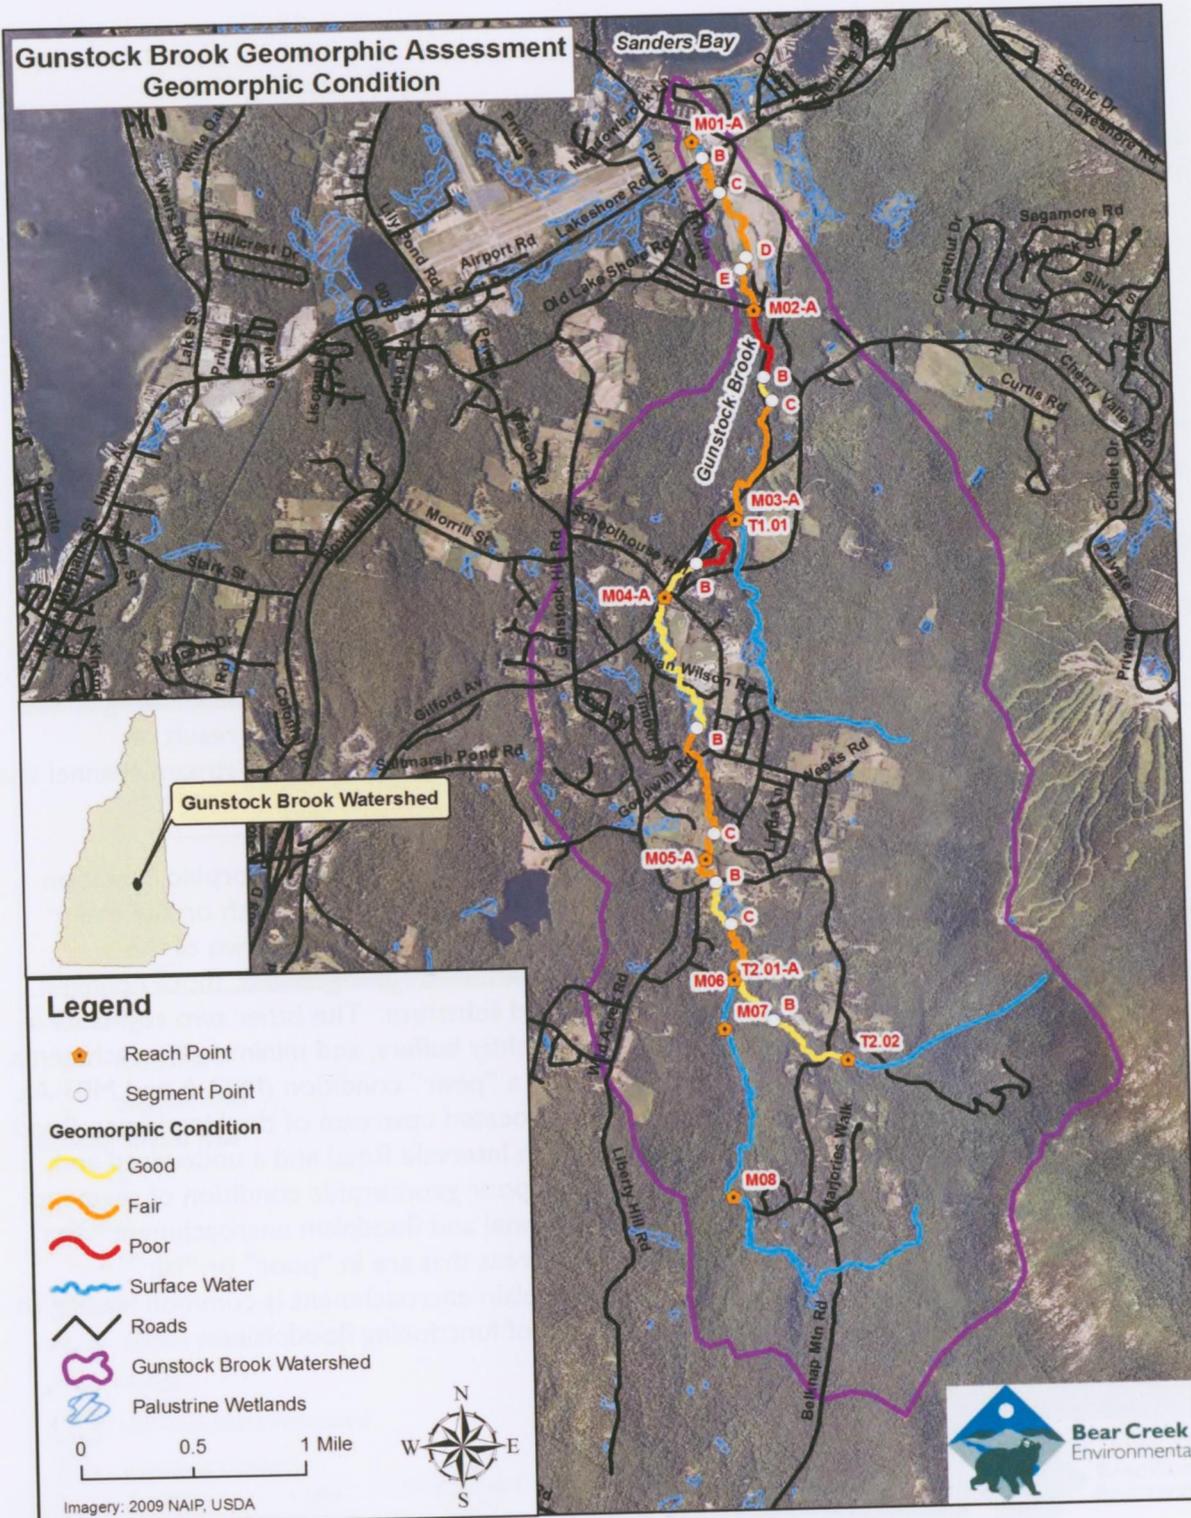
Figure 5.1. Phase 2 Geomorphic Condition of the Gunstock Brook Watershed

Four segments along the main stem of Gunstock Brook are in “good” geomorphic condition (M02-B, M03-B, M04-A, and M05-B). In addition, the most downstream reach on the major tributary to Gunstock Brook (T2.01) is in “good” geomorphic condition. Two of the Gunstock Brook segments in “good” condition are located in higher gradient, more confined sections with step-pool bedform and cobble dominated substrate. The other two segments in “good” condition are surrounded by wetland, have healthy buffers, and minimal encroachments. All of the remaining segments except two, which have a “poor” condition (M02-A and M03-A), are in “fair” geomorphic condition. Segment M02-A, located upstream of the Henderson Road crossing is impacted by floodplain encroachments from Intervale Road and a undersized and poorly aligned bridge crossing at Intervale Road. The poor geomorphic condition of segment M03-A is related to extensive straightening of the channel and floodplain encroachment from development near the Gilford Town offices. In the areas that are in “poor” or “fair” condition, significant instream modifications and floodplain encroachment is common leading to an increase in stream power in the channel and a loss of functioning floodplains.

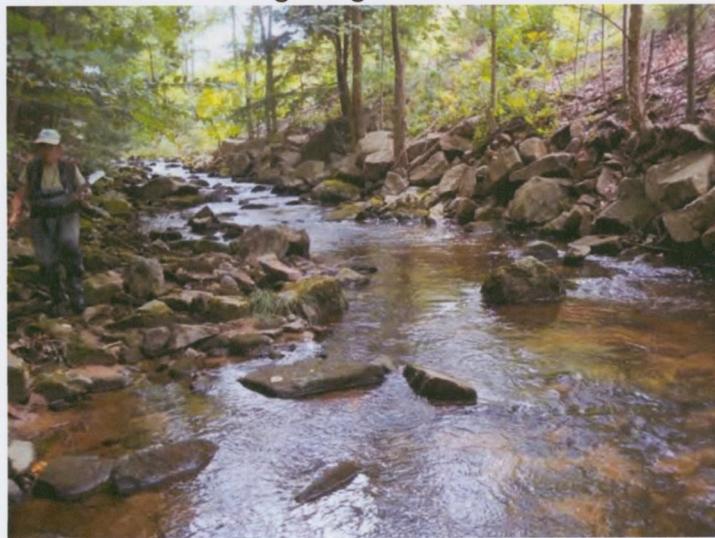
Figure 8.21. Natural cobble dominated "Fb" channel in M03-B.

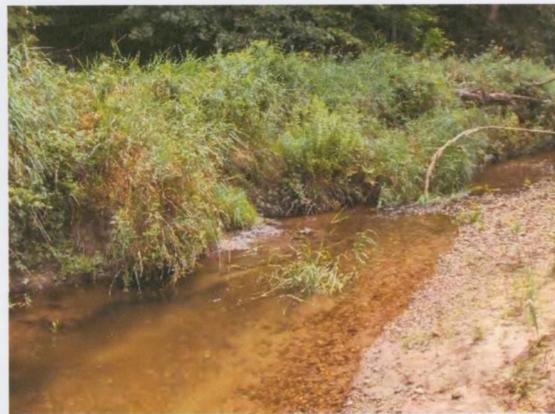
Figure 8.25. Typical wetland channel in M04-A.

Based on the Phase 2 assessment, both the geomorphic and habitat conditions of segment M04-A are “good”. The stream type is a gravel dominated “C” stream which has not incised. Segment M0-4A is undergoing minor aggradation with some diagonal and point bars and limited planform change with the presence of an island. Abundant large woody debris, coarse particulate organic matter and deep pools that are providing suitable water depths for fish and amphibians has contributed to the “good” habitat condition. Alders are the dominant vegetation on the banks. Given the prime riparian condition and wetland habitat, a 1,890 foot length of Segment M04-A is recommended for conservation to protect it from future impacts and to maintain the function of the wetland it flows through (Project #14).

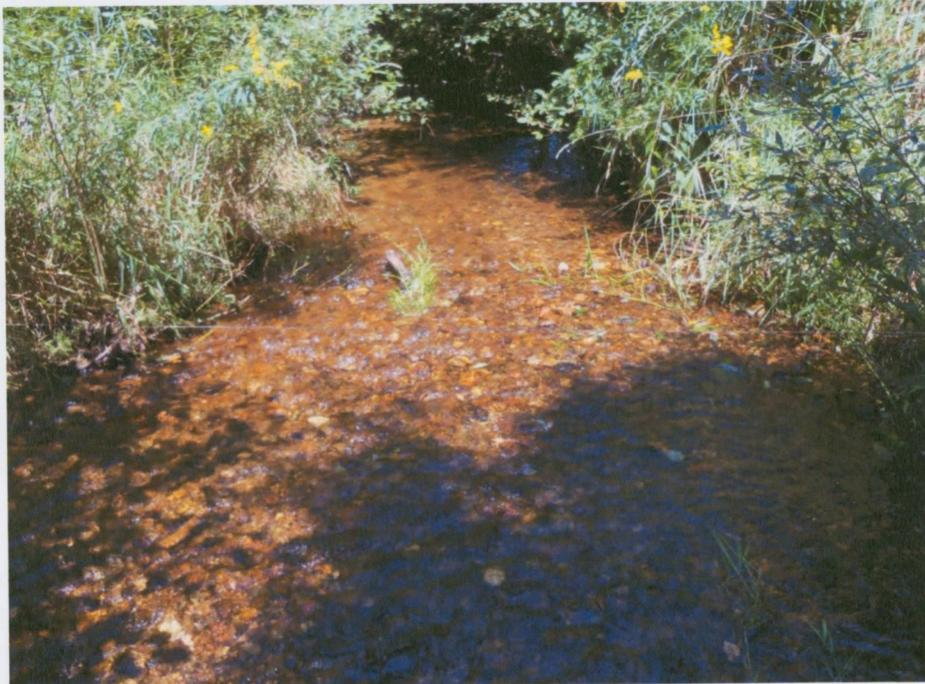
The banks are well vegetated (Figure 8.35) along most of the segment except where there is no vegetated buffer by one of the bridges and the lawn on the western side. One major impact in M05-A is that it has been straightened at the downstream end for approximately one third of its length. The channel alteration most likely led to the major incision observed in M05-A. The channel has not yet widened. The stream type is a gravel dominated "C" stream with riffle-pool bedform. There is minor aggradation in the segment as observed through some steep riffles, diagonal bars, point bars, side bars, and mid-channel bars. Planform has changed somewhat due to the aggradation, but not as pronounced as in reaches upstream from here.

Both the geomorphic and habitat condition resulted in a "fair" score. The "fair" geomorphic condition was primarily due to the channel incision and channel alteration. Compromised riparian area on the eastern side due to the hay field, lack of abundant woody debris, and loss of floodplain access contributed to the "fair" habitat condition.

Figure 8.35. Well vegetated banks in M05-A.

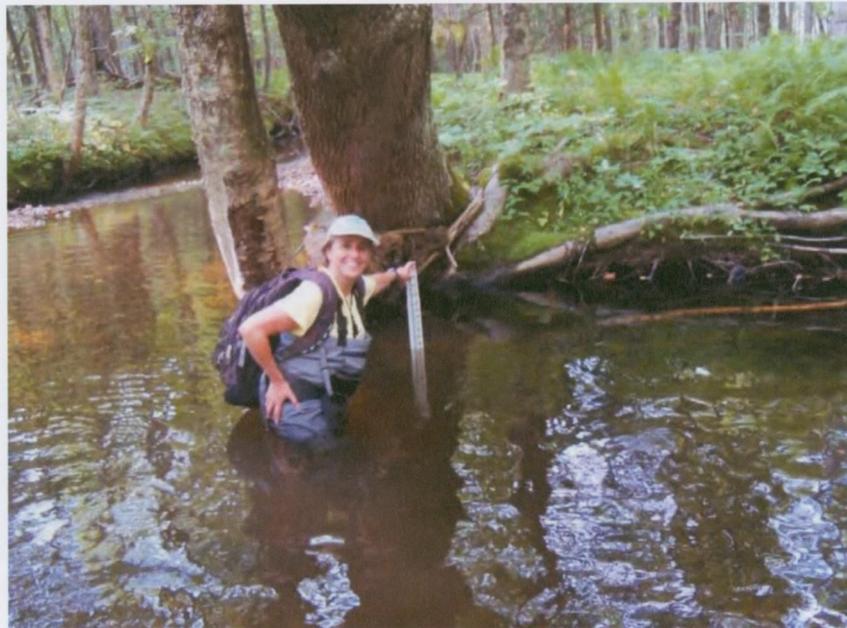
The RGA condition scored in the “fair” category due to the major aggradation and resultant planform adjustment. There was no incision in this Segment M05-C and the channel therefore has good access to its floodplain. The RHA scored in the “good” category mostly due to the nice undercut banks and pools (Figure 8.39) and well vegetated stream banks and riparian corridor. Given the high quality buffer and corridor conditions and habitat, it is recommended that Segments M05-B and M05-C be considered for conservation (Project #18). These two segments serve as key flood and sediment attenuation sections of Gunstock Brook and development within the corridor would jeopardize the ability for them to continue to provide flood and sediment retention.

Figure 8.39. Deep pool and nice undercut bank in M05-C.

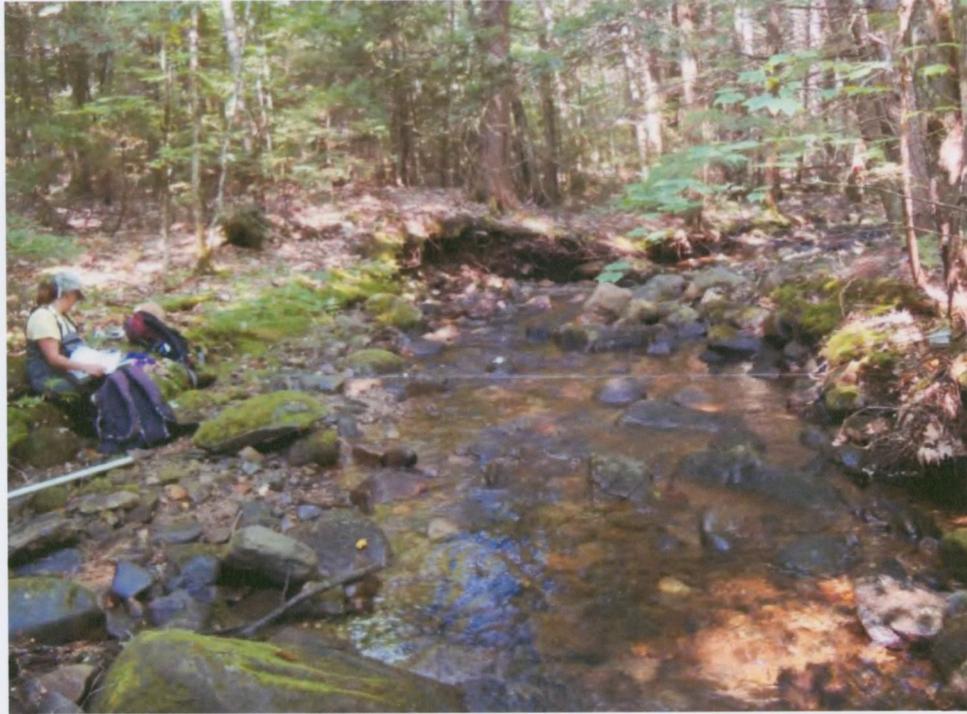
Segment T2.01-B begins where the valley becomes narrower and continues approximately ½ mile until 450 feet upstream of Belknap Mountain Road. Like T2.01-A, the banks and buffers are well forested in Segment T2.01-B. There has been no incision based on the cross section measured in this segment (Figure 8.42). Some banks are higher but this is more a function of natural floodplain variability than incision. There is very little erosion indicating that the segment is not widening. The stream type is a gravel dominated “C” channel with a slope of a “B” channel that has a dominant bedform of riffle-pool with a subdominant bedform of step-pool (upstream of Belknap Mountain Road). The channel is in the first stage of the channel evolution model, indicating it stable condition. All geomorphic processes were scored in the “good” or “reference” category. The lack of channel alteration, high quality banks and buffers, minor erosion and channel migration is indicative of the “good” geomorphic condition. The habitat condition also scored as “good” as a result of abundant pools, good hydrologic characteristics, nice undercut banks (Figure 8.43), and high quality banks and buffers.

Figure 8.42. Cross section in T2.01-B showing good floodplain access.

Conservation of reach T2.01 is recommended to provide continued flood and sediment attenuation (Project #20). Flood and sediment attenuation is important to prevent further transport of sediment to Gunstock Brook.

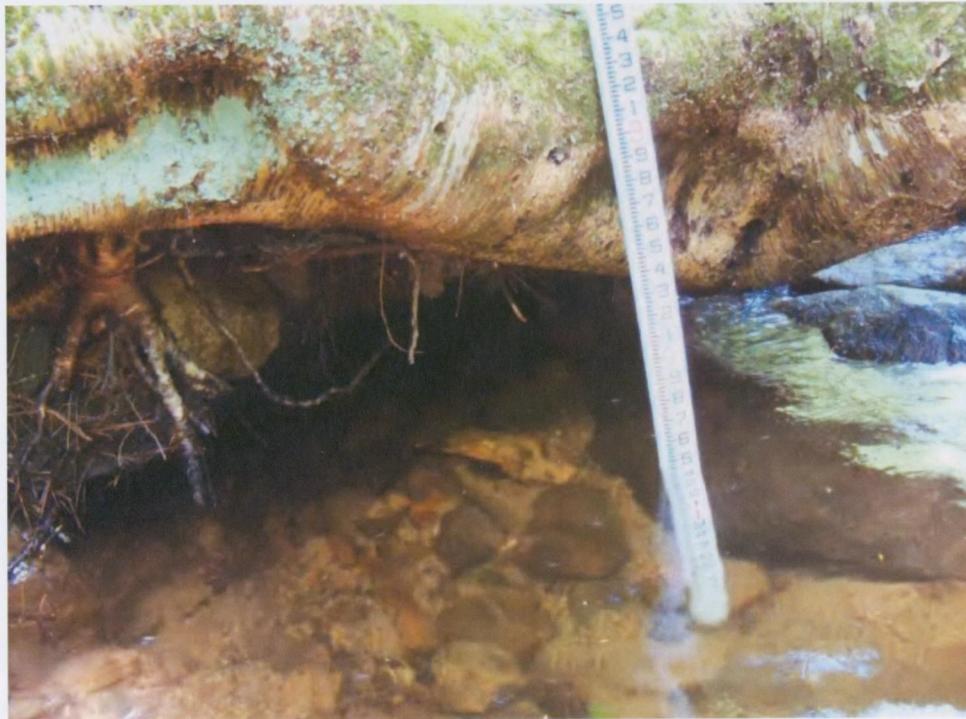
Figure 8.43. Nice undercut in T2.01-B providing cover for aquatic species.
