THE BENJAMIN ROWE HOUSE
COMMITTEE REPORT
AUGUST 1991

Arthur Tilton, chairman
Kathy Francke
Gilford School Board
Pat LaBonte, selectman
Adair Mulligan

On 2 June 1989, the Selectmen established a committee to study the future of the then named Alvah Wilson House. The following findings and recommendations are the result of the committee's works to fulfill the goals and objectives adopted at that time.

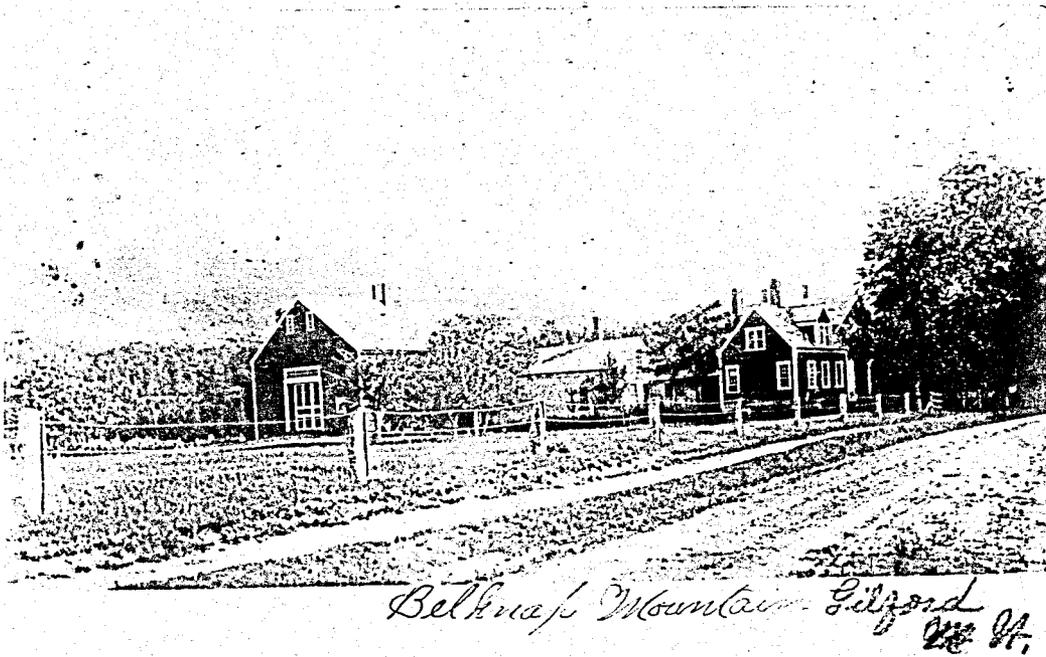
Illus. 2 (from the collection of Robert Holman)

Beginning in March 1991, members of the Rowe Committee began a series of "architectural archaeology digs" in an effort to establish the age of the wooden ell and the dormers. A c. 1900 postcard, reproduced for Gilford Public Library, shows the Rowe House with a 1 1/2 storey dormered ell, a "typical" open porch, and the original out-buildings. (Illus. 2)

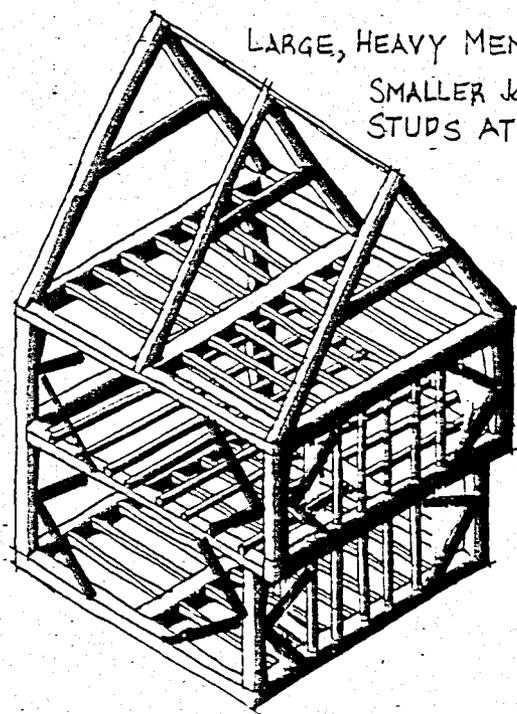
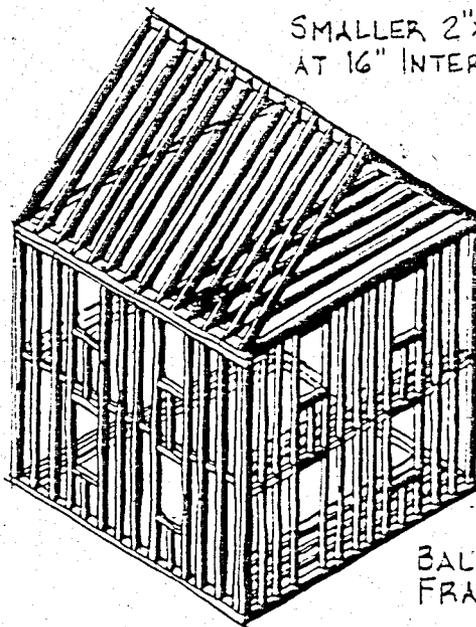
Illus. 3 (Hart and Hance, 1978, p.66)

Two areas were targeted for exploration: The wall adjoining the brick structure, and the northwest corner of the ell. If the ell did contain elements of Jesse Thing's house, there would be post and beam construction with gunstock posts, windbraces, and riven lath. (Illus. 3,4)

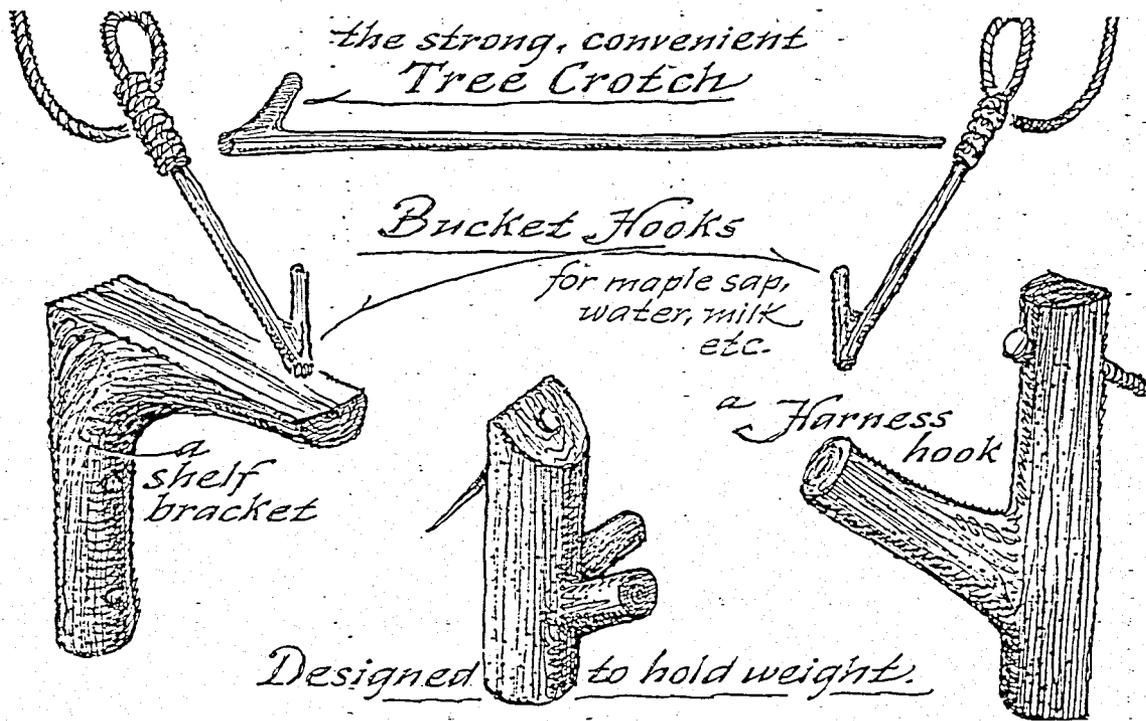
Illus. 31 (Eric Sloane, 1965, p.39)

A final charismatic note of dormer intrigues was the presence of what is assumed to be "drying pegs": wooden hooks hung along the rafters, made from branch crotches in the tradition described by Eric Sloane. (Illus. 31,32)
